TO: ALL ROOTES GROUP DEALERS

SUBJECT: GEARBOX NOISES

MODEL: SUNBEAM ALPINE

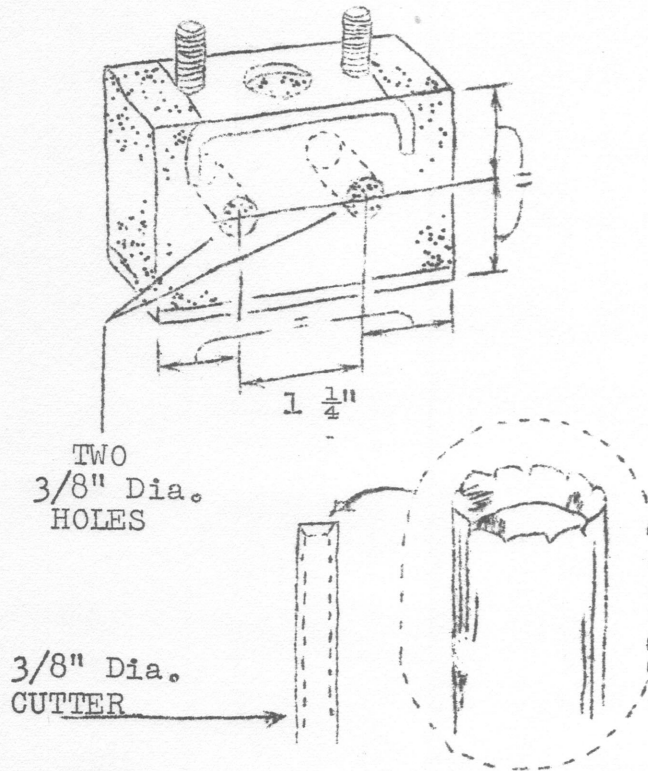
ENCL: Sketch No. 6744

Where complaints of excessive gear noise are received, the following Service action should be taken, which will assist in reducing noise level.

The rear engine mountings should be removed and two 3/8" holes should be drilled in each rubber in the position shown on the illustration. A suitable method of carrying out this work is to make up a tool as follows:-

Obtain a piece of good quality steel tubing, 5" to 6" long having a 3/8" outside diameter and as thin a gauge as possible. Squaring off one end and turn, grind or carefully file a chamfer on the inside, so leaving a sharp cutting edge. File a number of teeth in this edge as shown on the illustration, in order to assist cutting of the rubber.

Using a high speed drill and water, drill the rubbers in the position shown. Care should be taken to ensure that the rubber core left inside the rubber, is removed after each drilling.
