OCTOBER 1963

SUBJECT: FUEL TANK GAUGE UNITS KNOCKING.

MODEL: HILLMAN SUPER MINX SERIES II.

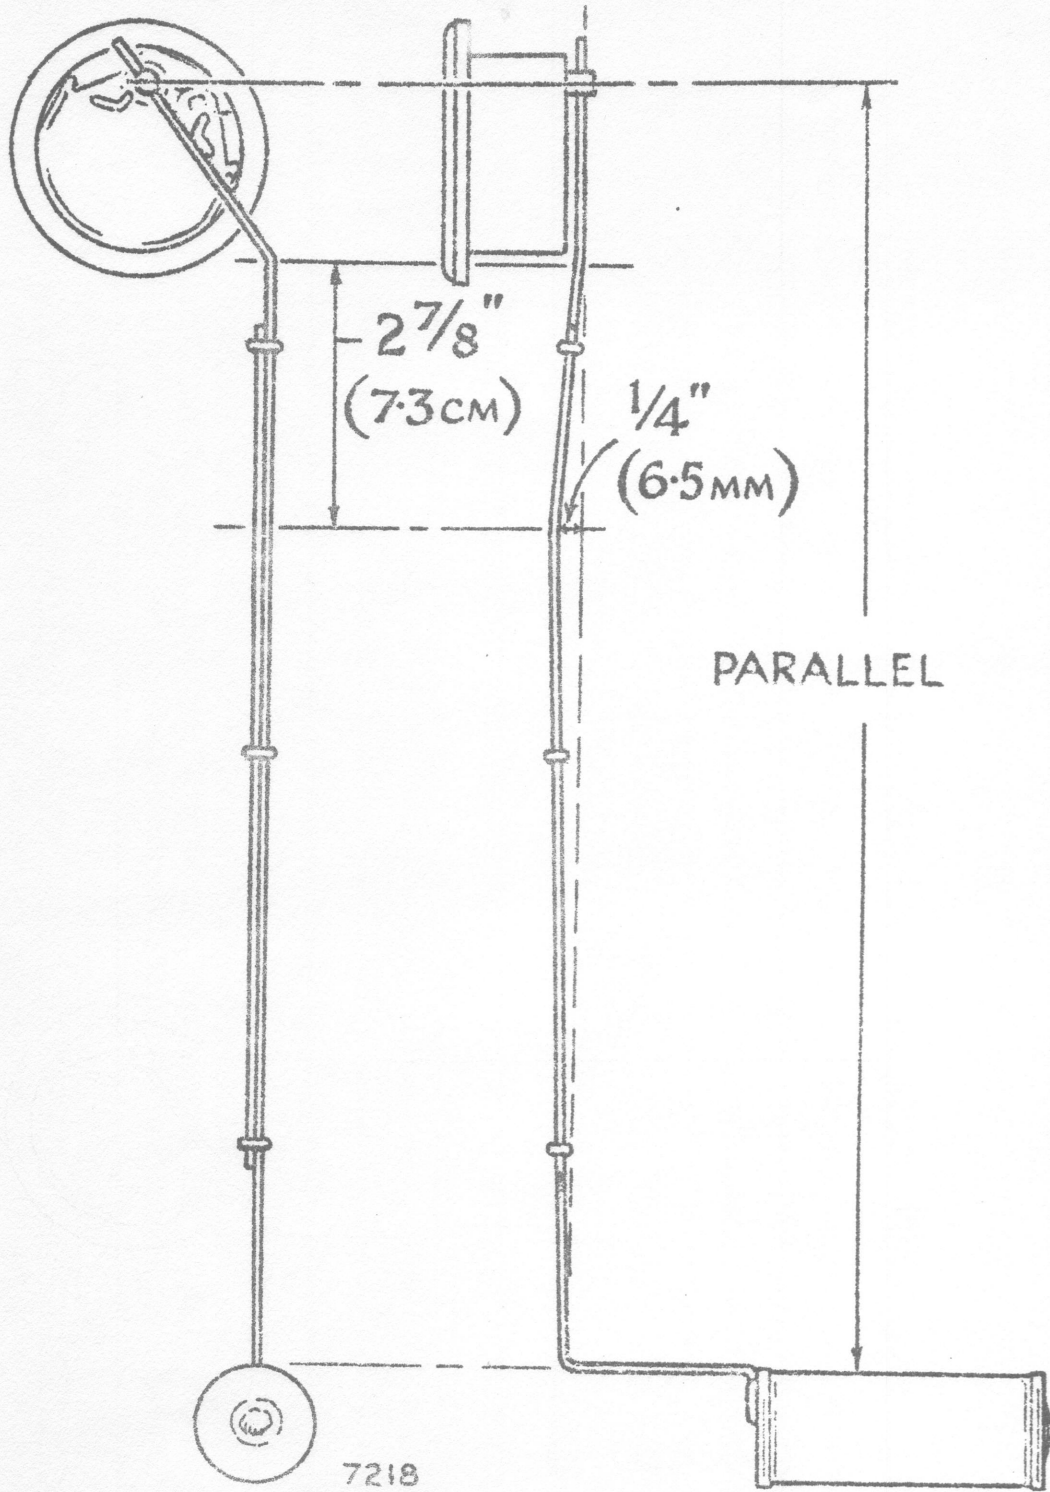
Under certain conditions, more particularly when the tank is only part full, it may be possible to hear the float knock in the fender-fitted fuel tank. This is usually the result of a slight foul between the tank baffle and float arm, sometimes aggravated by the float itself contacting the tank walls.

To overcome this, reshaping of the float arm to increase its clearance with the tank baffle is recommended.

As can be seen from illustration, No. 7218, the reshaping is a simple bending operation and in the main consists of  $1/4$ " (6.5mm) bow  $2-7/8$ " (7.3cm) from the arm kink. Care must be taken to ensure that the centre line of the pivot and float remain parallel.

At the same time, as a further precaution against knock, an additional neoprene anti-knock ring, Part Number 1202081, should be fitted  $1/2$ " from the float at the end which is not already fitted with a ring. This can be obtained through the normal Parts channels.
