SUBJECT: FUEL CONSUMPTION

MODEL: SUPER MINX

ENGINE 63/8

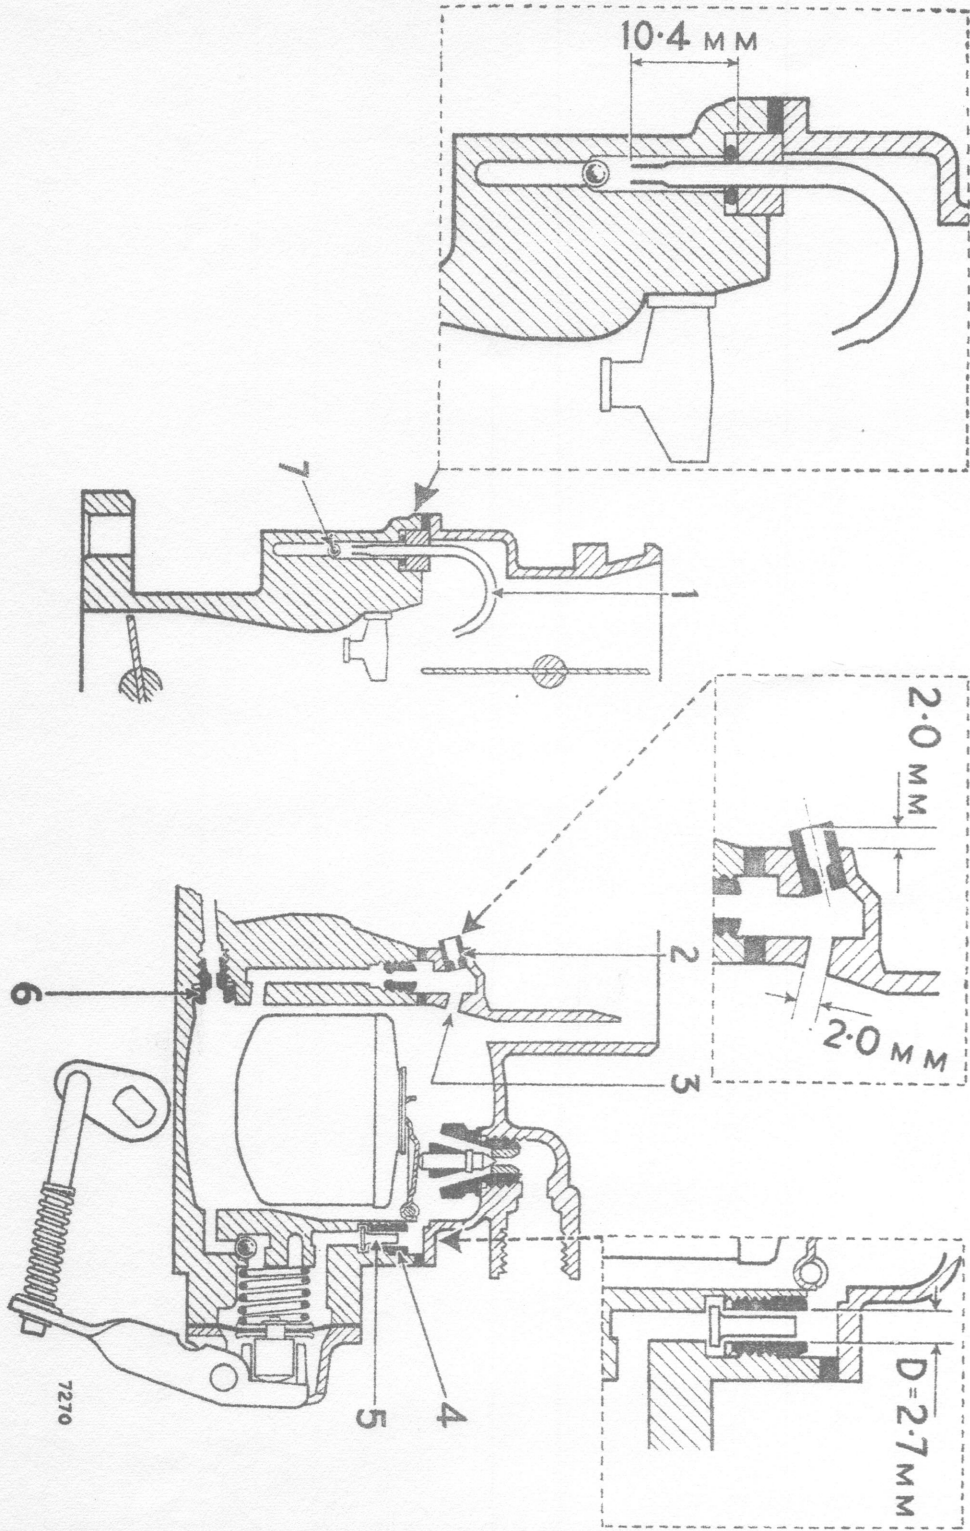
(1) Remove the carburetor float chamber cover and check the depth of the project of the "Econostat" discharge tube (2 on diagram) into the air stream - this should be 2 m/m taken from the centre line of the tube to the flat face from which it projects. If this measurement is not correct, renew the float chamber cover. Check also the "Econostat" air bleed drilling (3) at the back of the "Econostat" discharge tube - this should be cleared if necessary with a 2 mm (No. 47) drill.

(2) With the cover removed, check that the anti-syphon valve body is of correct size; the diameter should be 2.7 mm, this may be checked with a No. 37 drill. At the same time, check that the valve body (4) has not been over-tightened and that the anti-syphon valve (5) is not trapped on its seat, i.e. it must be free to move laterally. If the guide (4) is too deep, it should be replaced or approximately 1. mm ground carefully from the lower face.

(3) Remove the accelerator pump jet (1) and check that the small neoprene sealing ring beneath the hexagon is in position and in good condition and that the non-return ball (7) is in position below the injector tube. If the injector tube projects more than 10.4 mm. below the hexagon the ball will be trapped. If necessary, replace the injector tube.

(5) Ensure that a fibre washer is located under the main jet (6) and that it is not damaged.

(4) Check that the main spraying nozzle is secure. When doing so, ensure that the fixing screw is secured with sealing compound.

(6) After re-assembling the carburetor, ensure that there is a discharge from the accelerator pump jet when the throttle control is operated.
