COOLING SYSTEM

NoA-4

January, 1965

TO: ALL ROOTES DEALERS  
MODEL: SUNBEAM IMP  
SUBJECT: WATER PUMPS

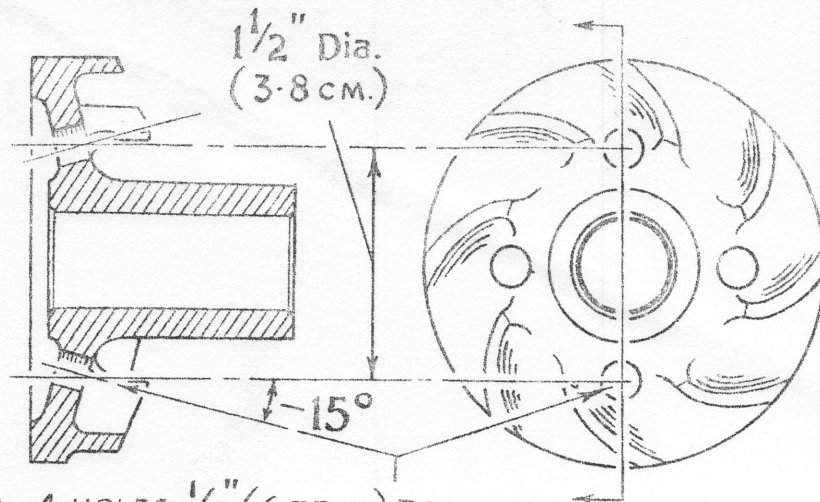
Examine the impellor and shaft assembly bearing surfaces for pitting and corrosion, paying particular attention to both locations on which the seal carbons bear. If any pitting evident, replace the impellor and shaft assembly, Part No. 7100413. This assembly is not part of the repair kit and must be ordered separately.

If not already incorporated, modify the impellor by drilling four 1/4" (6.35 mm) diameter holes between the vanes, See Fig. 1. No attempt should be made to dismantle the impellor from its driving spindle.

DRILL 4 HOLES 1/4" (6.35mm) Dia.

EQUALLY SPACED AND BETWEEN VANES AS SHOWN

NOTE :- NO ATTEMPT IS TO BE MADE TO DISMANTLE THE IMPELLOR FROM ITS DRIVING SPINDLE . SHOULD EITHER THE IMPELLOR OR THE SPINDLE BE DAMAGED IT WILL BE NECESSARY TO FIT A NEW MATCHED ASSEMBLY.
