FUEL SYSTEM

No. C-11

MODEL: LIGHT CAR RANGE (1725 cc CAST IRON  
HEAD ENGINE)

SUBJECT: CARBURETOR ICING

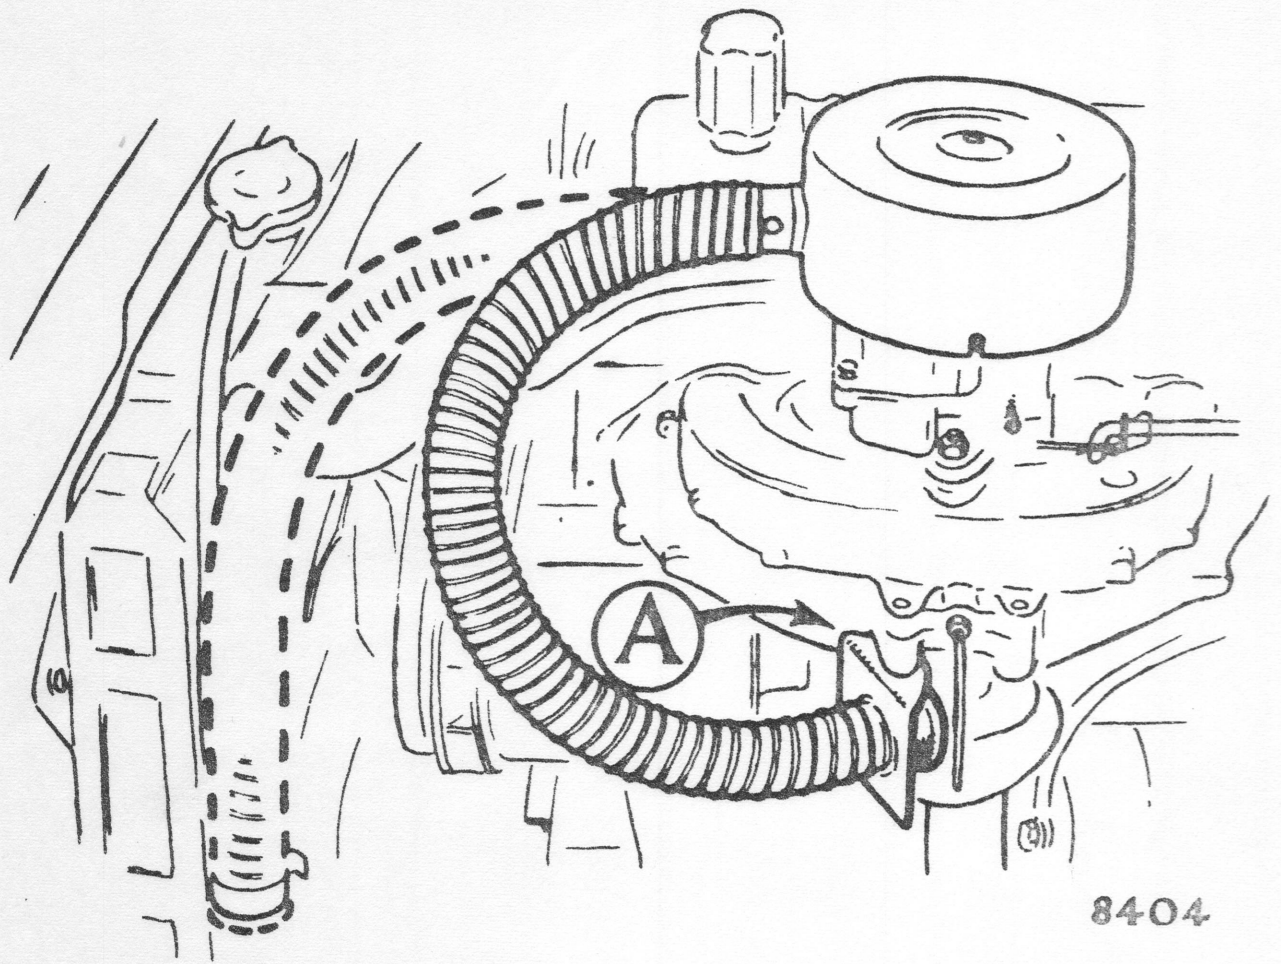
8404

Where called upon to investigate complaints of carburetor icing causing engine stalling and in severe cases total loss of power during the warm up period in the winter months, it is recommended that the following action is taken:-

A carburetor de-icing bracket, Part No. 1238410, should be fitted to the front outer bolt of the manifold hot spot as follows:-

- 1) Remove front outer hot spot bolt together with plain washer.
- 2) Open mounting flange of de-icing bracket in order that the displaced bolt and washer can be fitted through the bracket.
- 3) After fitting bolt through bracket, re-align flange to original position.
- 4) Refit bolt together with bracket to front outer position of hot spot and tighten bolt, so positioning the bracket that its inner edge butts against the exhaust manifold as shown 'A' in illustration.
- 5) Remove air cleaner intake hose from clip on side of radiator, at the same time withdrawing the metal intake flange. (This flange should be retained in the car for Summer use).
- 6) Position open end of intake hose on de-icing bracket.
