FUEL SYSTEM

C-3

TO: ALL ROOTES GROUP DEALERS  
MODEL: SUNBEAM IMP  
SUBJECT: MECHANICAL THROTTLE CONTROLS

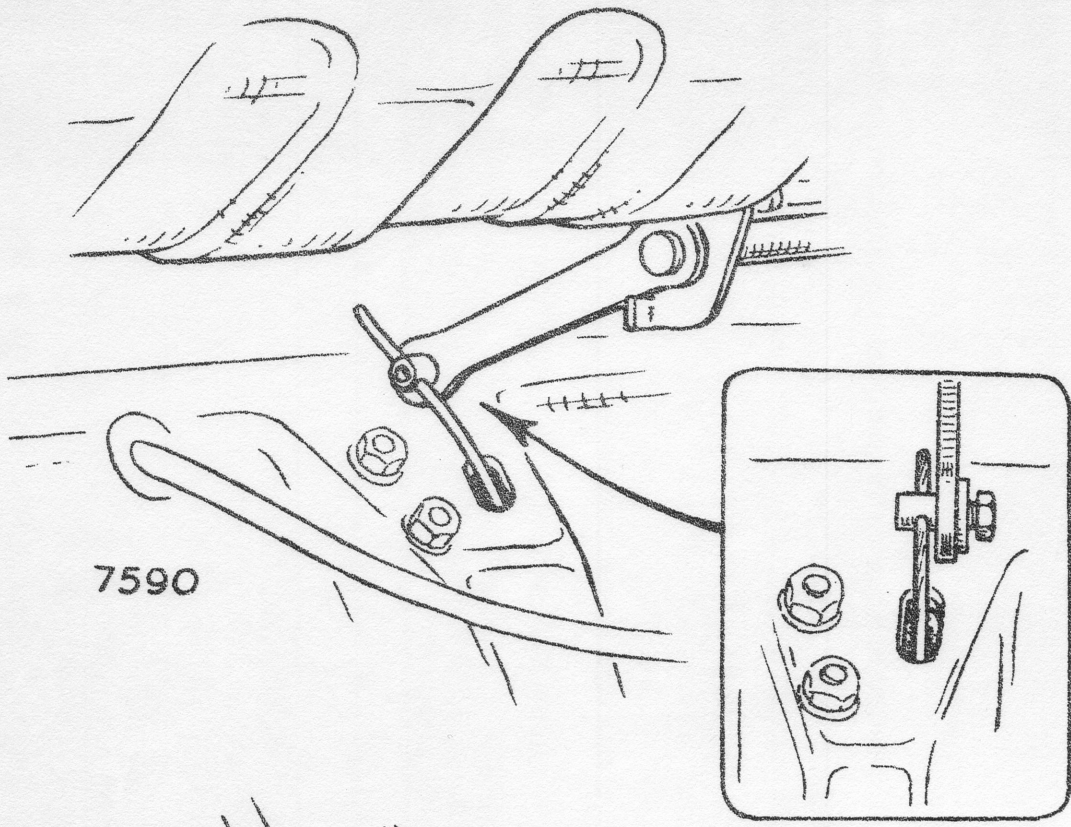
7590

1. Examine the run of the cable under the car and make sure that it is not trapped, and that there are no sharp bends.
2. Rectify any misalignment of the operating levers at either end of the cable, ensuring that the inner cable emerges squarely from the mouth of the outer and does not bind on the side. See illustrations overleaf.
3. Check for tight or sticking pivot points anywhere in the system.

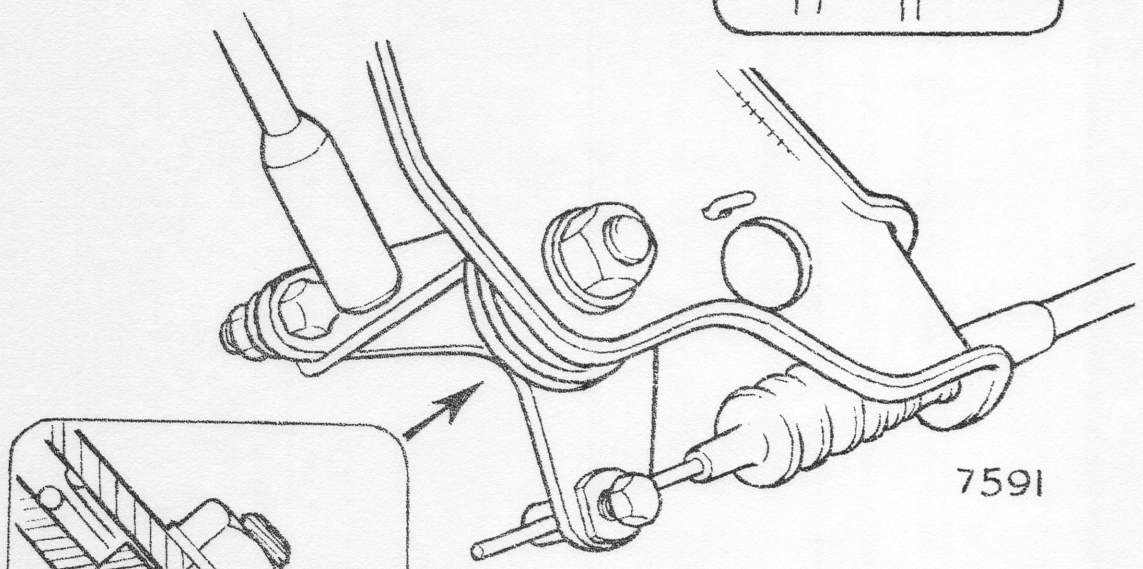
7591

A possible foul condition illustrated overleaf may exist due to an oversize shank on the relay lever pivot pin causing the relay lever to bind on the support bracket. There should be a clearance of at least .010" (.25 mm) at the point shown in the illustration. This can be obtained if necessary by filing the face of the relay lever.

$\cdot 010''$  ( $\cdot 25$  M.M)  
CLEARANCE - MINIMUM
