November, 1964

MODEL: SUNBEAM IMP

SUBJECT: CARBURETOR - CABLE OPERATED THROTTLE CONTROLS  
(1) STICKING THROTTLE (2) INABILITY TO OBTAIN FULL THROTTLE

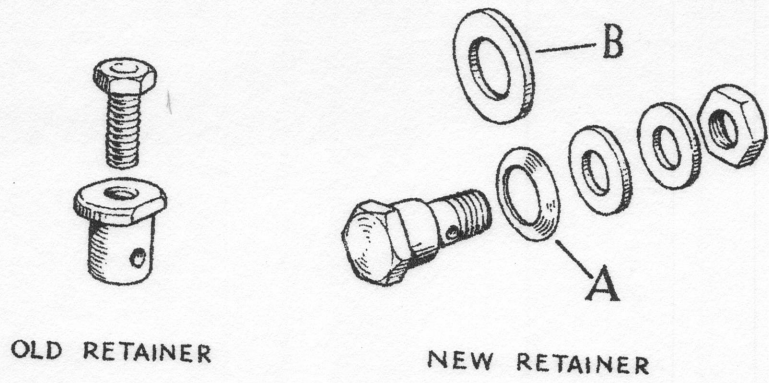
Fig. 1.

(1) STICKING THROTTLE - Further to the advice contained in Bulletin C-3, the more flexible cable referred to in Paragraph 5 is now available under Part No. 7095020 and has been fitted in Production from Chassis Nos. B.411065145 De Luxe and B.421002215 Standard.

With the introduction of the more flexible cable, new type retainers together with washers and nuts are fitted; these are sold as a kit under Part No. 7050097 (2 off per car). When replacing the old type cable with the new type, new retainers must be fitted.

The tightening torque for cable retainers front and rear is 12 lbs. ins. (.13 kgm).

Lubricate the retainers with MS.4 Silicone based grease and thereafter at 5,000 mile (8000 kms.) services.

NOTE - Waved washer (A) 9055017 not required at engine end.)  
Plain washer (B) 9067236 not required at pedal end. ) See Fig. 1

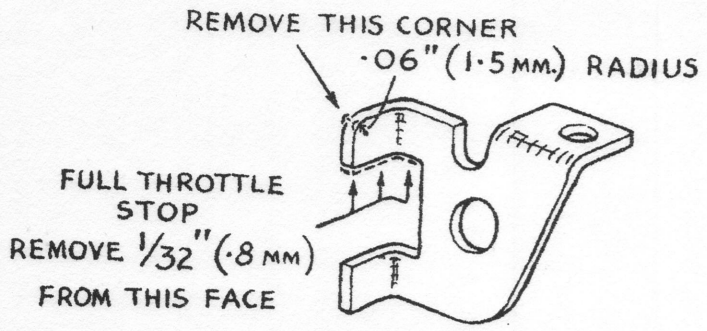
Fig. 2.

(2) INABILITY TO OBTAIN FULL THROTTLE - This may be caused by the stop bracket on the accelerator pedal and bracket assembly preventing full movement of the cable operating arm. Remove the assembly from the vehicle and modify the stop bracket by removing 1/32" (.8 mm) from the contact surface of the full throttle stop only (See Fig. 2).

Radius the top corner of the stop bracket as shown in Figure 2 to avoid the possibility of a foul against the toe board swaging.

Refit pedal assembly, check for full and free movement and adjust slow running.
