GEARBOX AND
OVERDRIVE

No. E-18

TO: ALL ROOTES DEALERS
MODEL: SUNBEAM IMP
SUBJECT: TRANSAXLE UNIT LUBRICATION

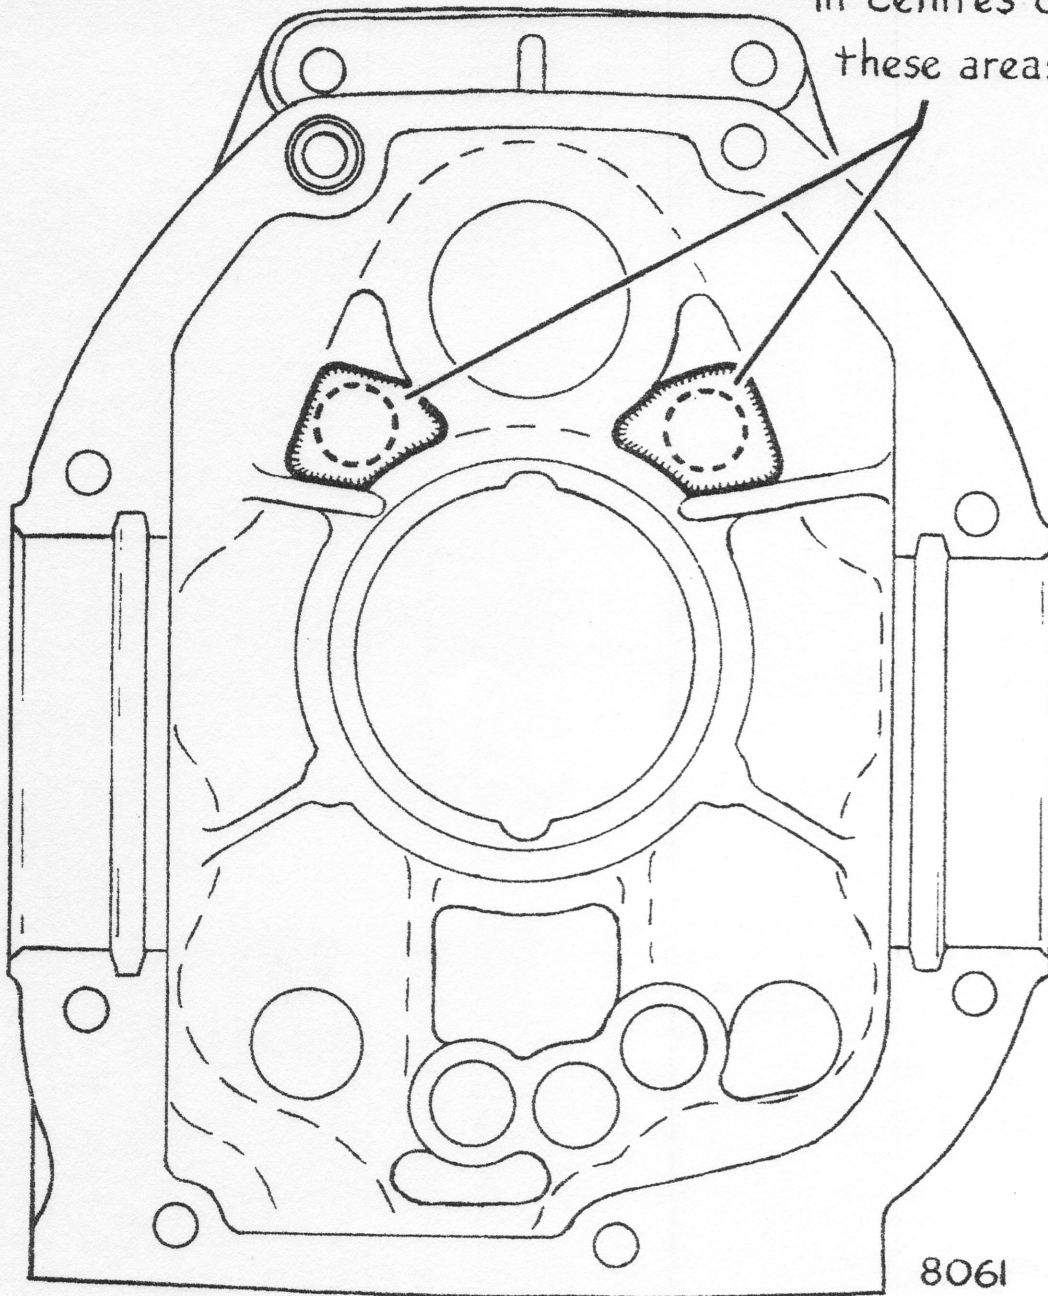
8061

In order to improve the internal distribution of transaxle lubricants, two holes are now drilled in the Hypoid to gearbox casing wall from the following Chassis Numbers:-

Where it is found necessary for any reason to overhaul the transaxle units on vehicles prior to the above Chassis Numbers, we would ask you to ensure that during the course of this work, two 9/16" (14 mm.) dia holes are drilled through the Hypoid to gearbox casing wall as shown on the attached illustration.

Drill $\frac{9}{16}$ " (14 M.M.) Dia. Holes
in centres of
these areas.
