TO: ALL ROOTES GROUP DEALERS  
MODEL: SUNBEAM IMP  
SUBJECT: TRANSAXLE UNITS

This bulletin is issued to provide additional guidance in instances where it is necessary to overhaul a transaxle unit, and has been compiled from experience gained in the Home Market.

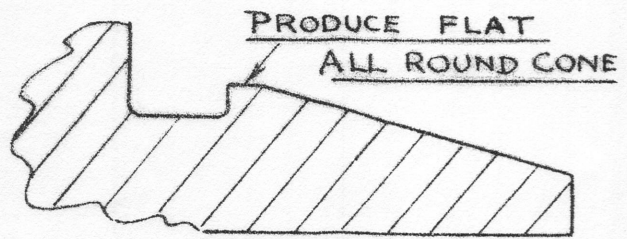
FIG. 1.

Check 1st gear dog teeth, if burred - replace with new 1st gear.

Remove the top edge of the cone by stoning carefully all round (Fig. 1). Do this on the new gear or to the old 1st gear if it is to be refitted.
