March, 1965

TO: ALL ROOTES DEALERS
 MODEL: SUNBEAM IMP
 SUBJECT: SHOCK ABSORBER NOISE.

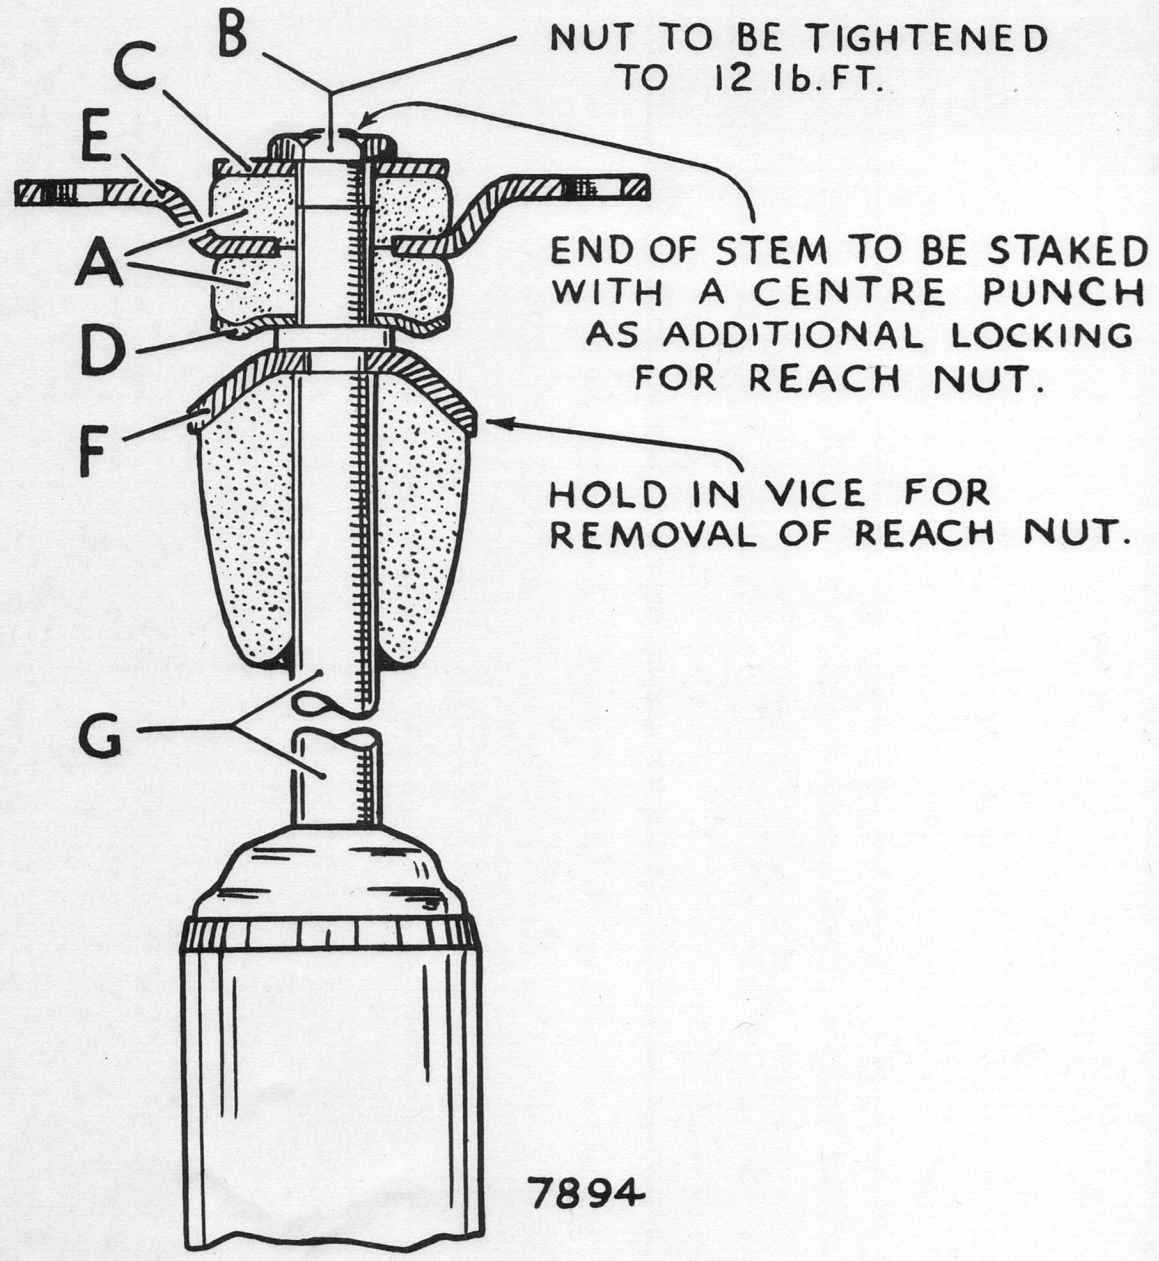
REAR SHOCK ABSORBERS

Where you are called upon to investigate complaints of rear shock absorber noise, the shock absorber mountings should be checked for tightness and if these are satisfactory, the following procedure should be carried out:-

1. Remove shock absorber from vehicle.
2. Grip the shock absorber lightly in a vice by the bump rubber location disc (F on illustration) taking care to ensure that the working surface of the piston rod (G) is not damaged.

3. Remove the reach nut (B) the upper retaining washer (C) the cushion rubbers (A) the upper mounting plate (E) and the lower retaining washer (D).
4. Clean the 3/8" UNF threads at the top of the piston rod using a 3/8" UNF die.

5. Fit replacement cushion rubbers (A) Part No. 7102949 and examine the upper mounting plate (E) Part No. 7102951; replace if necessary.
6. Refit new and old parts in the reverse order that they were removed, using a new reach nut (B) Part No. 7102945. Torque the reach nut to 12 lbs. ft. (1.6 Kg.m) and stake the nut, using a suitable centre punch.

7. Prime the shock absorber and refit to the vehicle as described in Workshop Manual 141, Section F. Page 13.
