SUSPENSION AND  
DAMPERS.

No. H-2

TO: ALL ROOTES GROUP DEALERS  
MODEL: SUNBEAM TIGER, (260),  
SUBJECT: PANHARD ROD BRACKET FAILURE

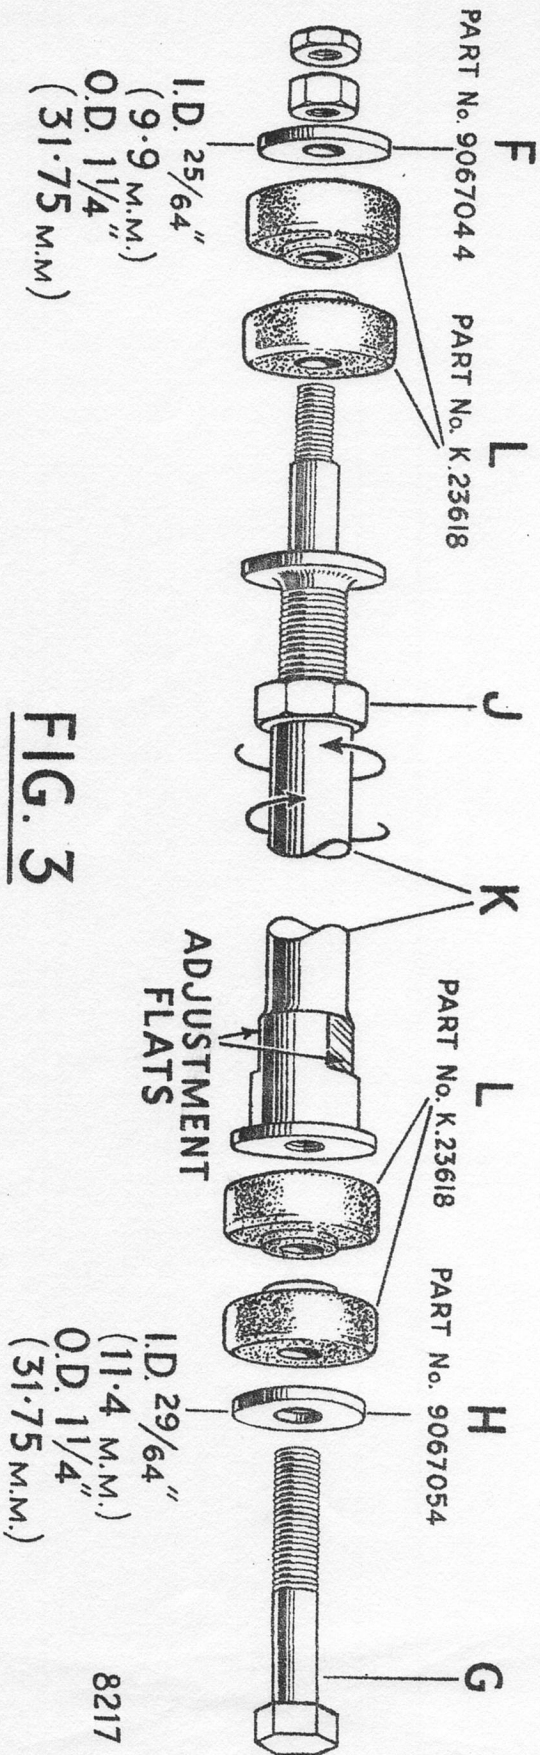
**FIG. 3**

In order to minimise the possibility of Panhard Rod Bracket failure on the above model, all cars prior to Chassis Number B.9473544 should be checked at the next Service call to ensure that the correct washer, Part Number 9067044, is fitted at the chassis frame end of the Panhard Rod as shown on the attached illustration.

Both locknuts 'M' should be removed together with the plain washer 'F'. The internal diameter of this washer 'F' should be 25/64" (2.9 mm.); if greater, the washer must be replaced with Part Number 9067044, and the old washer discarded.

The new washer should be fitted, both locknuts retightened and the Panhard Rod adjusted as follows:-

1. Load vehicle with 165 lbs. (75 kgs.) in the boot, 20" (50 cms.) rearwards on the centre line of the rear axle.
2. Slacken locknut 'J' and adjust Panhard Rod tube 'K' by turning it clockwise or anti-clockwise until the rubber bushes 'L' mounted on either side of the Panhard Rod bracket 'N' are of equal thickness, i.e., when there is no tension or compression in the rod, as shown.
3. Tighten Panhard rod locknut 'J' and remove weights from vehicle.
