TO: ALL ROOTES DEALERS

MODEL: SUNBEAM TIGER

SUBJECT: SHOCK ABSORBER DAMAGE DUE TO VIOLENT
 STANDING STARTS

No. H-3

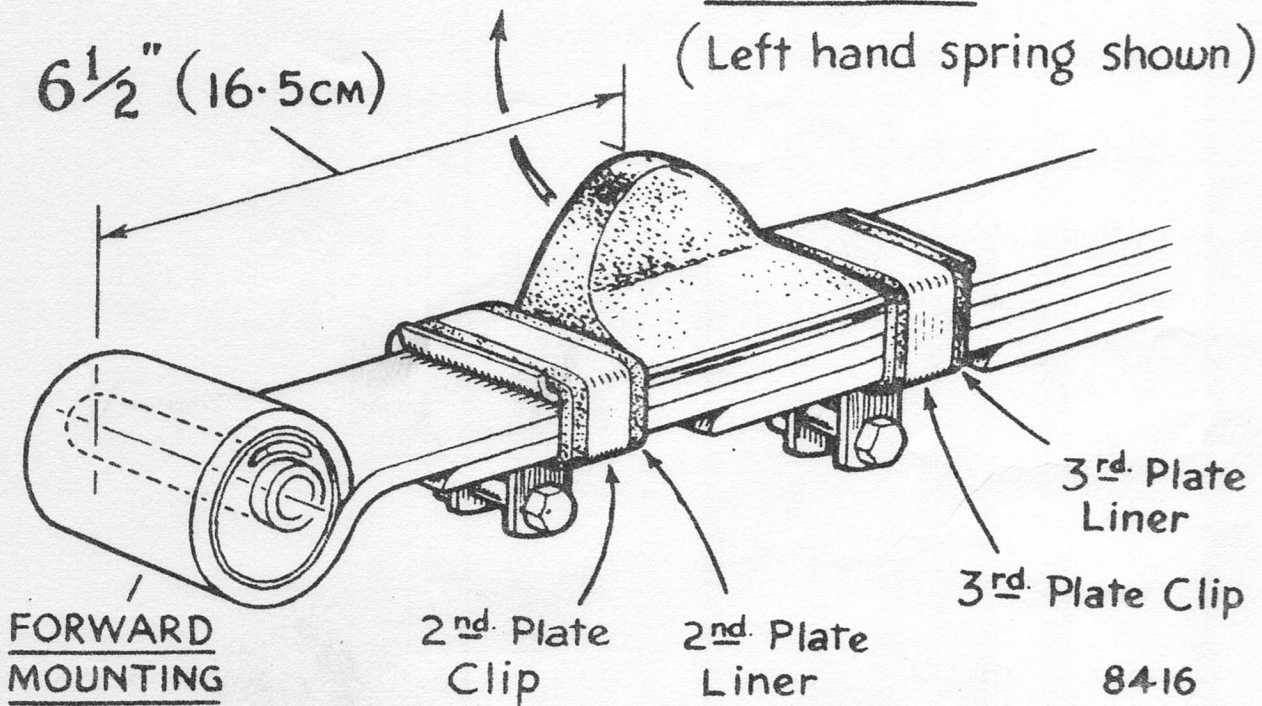
8416

A number of cases have been reported where rear shock absorbers have been damaged due to violent acceleration from rest, i.e., clutch released at high engine speeds on take off.

Vertical face of Torque Reaction Rubber
to face INWARDS

6½" (16.5cm)

(Left hand spring shown)

In order to reduce the risk of damage on cars which are driven in this manner, it is recommended that torque reaction rubbers are fitted as follows:-

- 1) Jack up car.
- 2) Remove and discard second leaf clip and rubber liner from the forward end of N/S rear road spring.
- 3) Remove all traces of foreign matter from the top surface of the spring for approximately 12 ins. (30 cms.) from the forward end.
- 4) Fit the torque reaction rubber, second and third plate in the position shown using bolts and nuts provided.
- 5) Repeat procedure on O/S spring.
- 6) Remove jack.
