BRAKES

No. K-2

MODEL: RAPIER IV, MINX V AND SUPER MINX II

SUBJECT: BRAKE SQUEAL AND ERRATIC SERVO ASSISTANCE AND NOISE

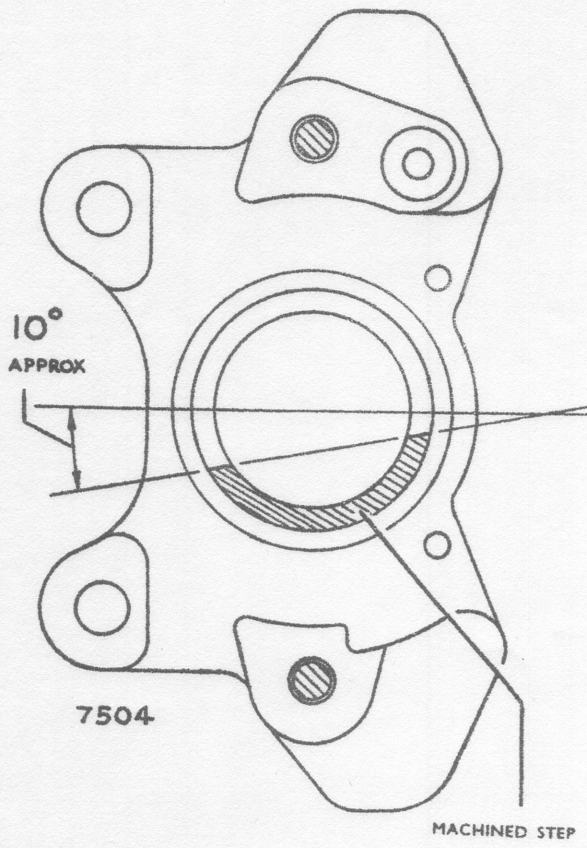
KL/jlk
Encl. Sketch No. 7504.

Where complaints are received in respect of 'squeal' from the disc brakes of the above models, this can be overcome by axially repositioning the caliper pistons.

The new position of the pistons is as shown in the accompanying illustration, that is with the machined step, 10° rearwards from the horizontal (previously vertical).

First, the disc must be checked for run out and end-float (hub end-float) and corrected if necessary in accordance with the Workshop Manual, section K and F respectively.

This change will entail removal and refitting the pistons which must be performed correctly following the instructions, Section K, using the special tool Number RG.331, remembering that the dust seals and retainers must be replaced.
