MISCELLANEOUS

No. 238

SUNBEAM ALPINE

BOOT LOCK

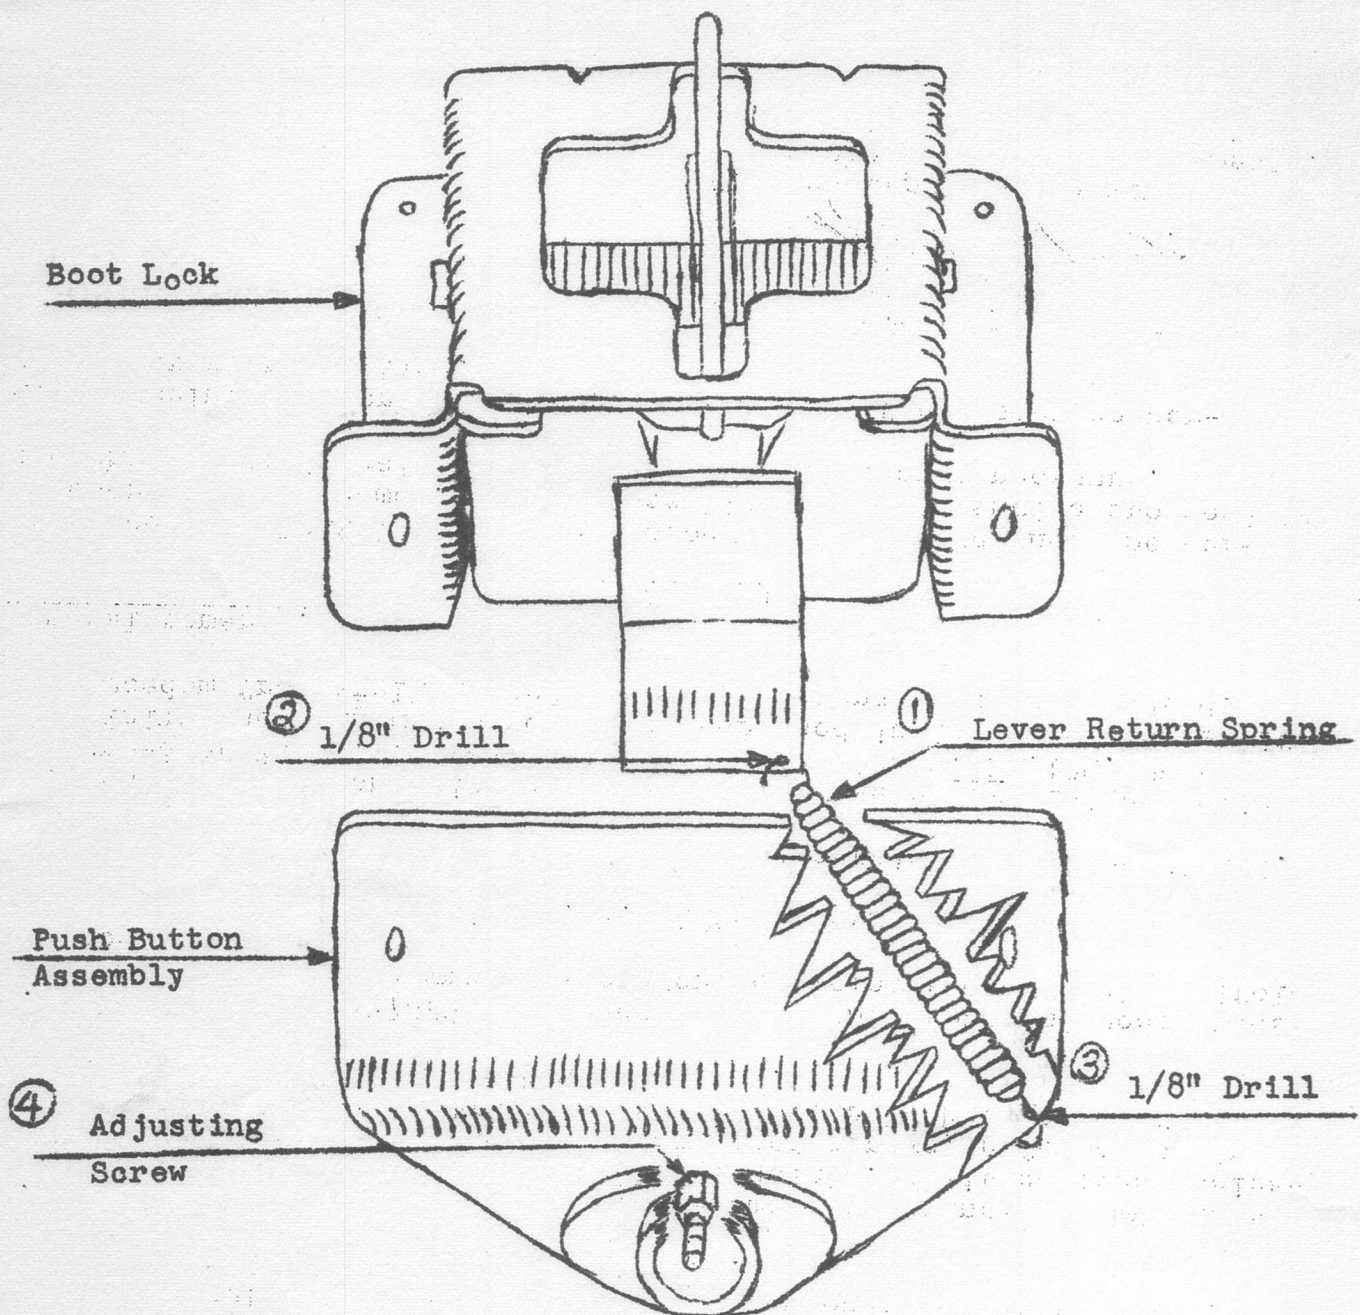
We have received a number of complaints from owners and Dealers relative to the boot lid of Sunbeam Alpines coming open when the vehicle is in motion.

Our overseas Production advises the cause of this has been relegated to the lack of sufficient tension on the retainer spring of the lock assembly itself and present production includes a higher tension spring being fitted.

To overcome this problem in service, however, attached is a diagram indicating a small modification which we know to be 100% effective in eliminating this problem.

1. Striker Plate Spring $1\frac{1}{2}$ " Long
5 - 7 lb. Pull
2. $1/8$ " Drill in striker plate
3. $1/8$ " Drill in lock housing
4. Striker Plate Screw to be adjusted
so that a clearance of .020 remains
between plate and screw.
