SERVICE BULLETIN

No. 62/4

HILLMAN SUPER MINX

POOR HEATER/DEMISTER PERFORMANCE

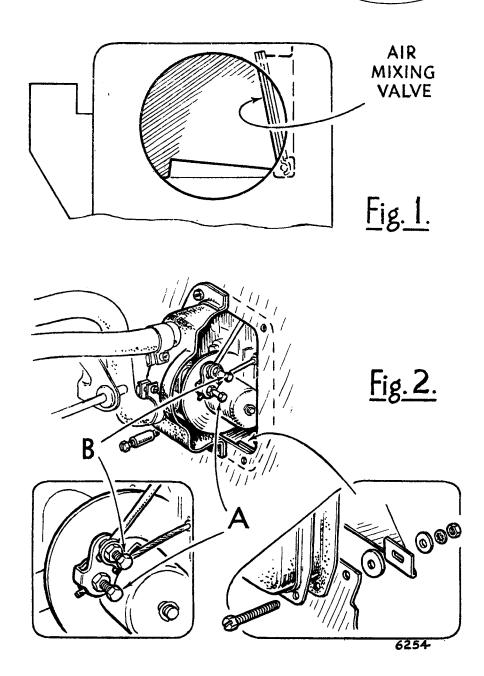
Where complaints of heater inefficiency are reported, it is important to ensure that the main air mixing valve within the heater is properly seating in the vertical position, when the 'Heat and Car' control is set to 'Hot'. See Fig. 1.

- 1. Remove the blower to gain visual access to the air mixing valve.
- 2. Set the 'Heat and Car' control to 'Hot' and check that the air mixing valve is fully closed in the vertical position. Observe this through the heater air inlet aperture in the blower recess. See Fig. 1.
- 3. If the valve is not seating correctly, re-adjust the 'Heat and Car' control cable at the heater unit end as follows:-

Release the water valve plastic cover. (Note that the lower outer securing screw is locked by means of a nut, at the lower heater bracket inside the car. See Fig. 2. Right Hand Inset.) Do not lose the packing washer fitted between the bracket and the bulkhead.

The retainer plate and the plastic cover can now be eased away to allow access to the water valve lever and trunnions A and B. Fig. 2.

Release trunnion screw A, ensuring that the water valve lever is fully forward (open). Close the air mixing valve to the vertical position by hand and retighten screw A. Should the connecting rod between the water valve lever and the air mixing valve restrict the closure of the valve, release trunnion screw B, close the valve by hand and re-tighten screw B.
