TO ALL ROOTES GROUP DEALERS

REUTTER AND BENCH FRONT SEAT FIXINGS

SERVICE BULLETIN NO. 261

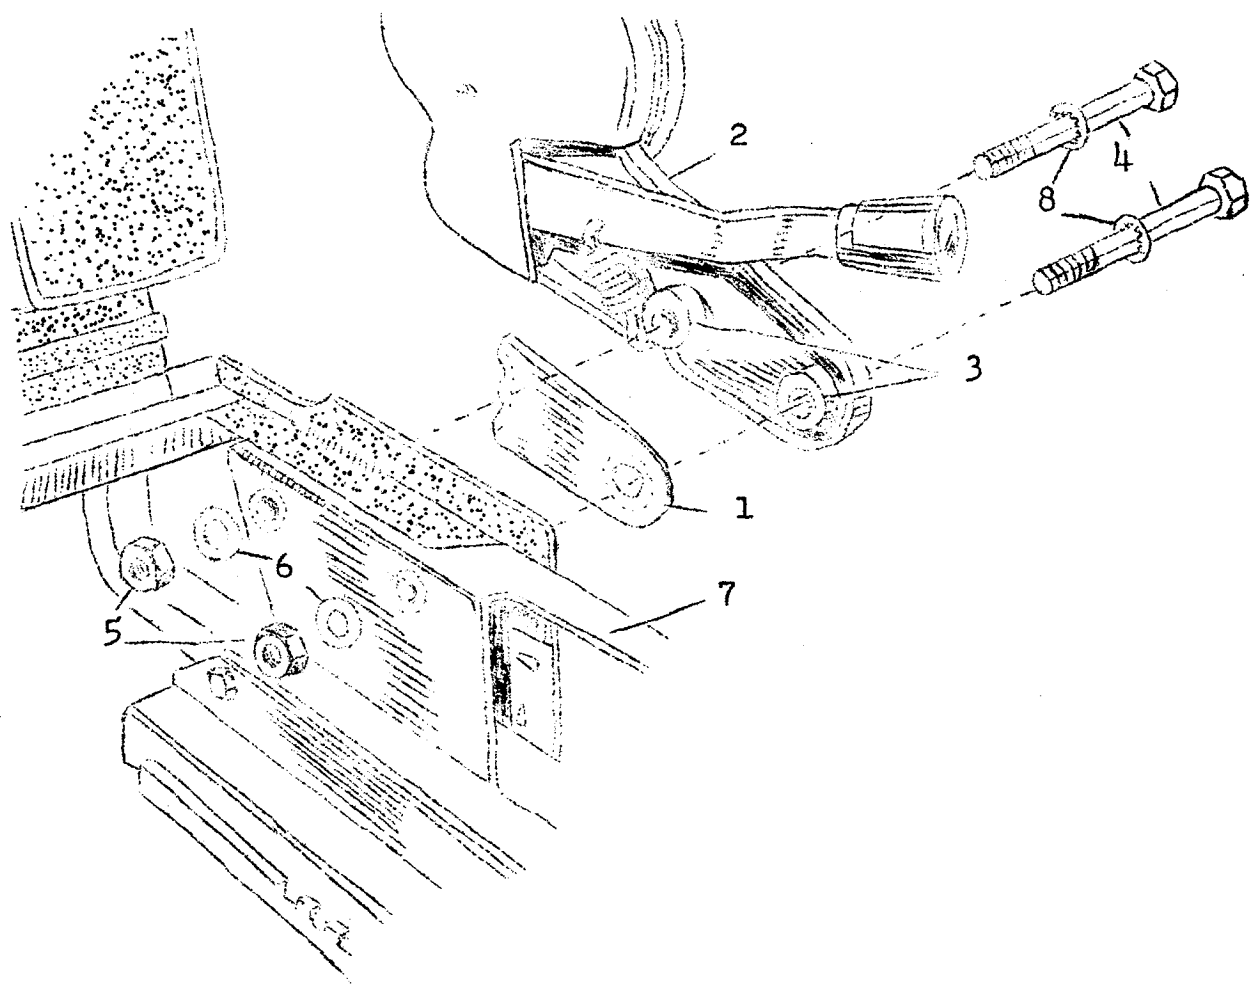
Where complaints are received of Reutter seats becoming loose, this may be due to the collapse of the aluminum quadrant cover (1) of the mechanism (2).

After the removal of the Reutter mechanism (2) it will be seen from the illustration how the cover plate (1) must be cut, as indicated by dotted lines.

To overcome this condition, the fixing holes (in the cover) must be enlarged to give clearance over the bolt bosses (3), and the trim in the same area should also be cut away to give the necessary clearance around the bosses.

When assembling the Reutter mechanism to the frame, lock washers (8) (Part No. 9664283) must be fitted under the bolt heads to stop the bolts from working loose in service. The original spring washers should be discarded.
