TO ALL ROOTES GROUP DEALERS

SOFT TOP ASSEMBLY - SUNBEAM ALPINE

SERVICE BULLETIN NO. 191 (Con't.)

SUNBEAM ALPINE SOFT TOP ASSEMBLY

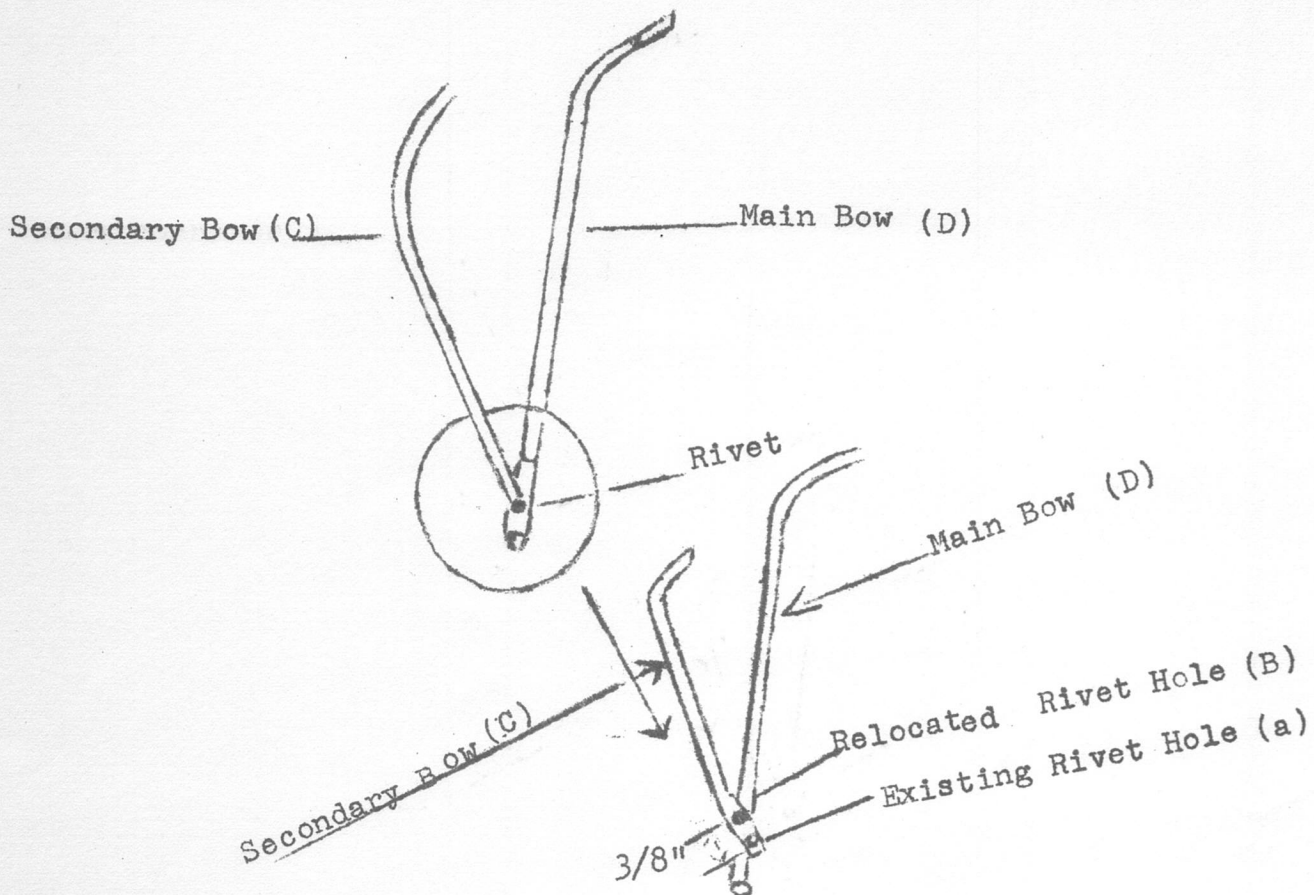
SUGGESTED MODIFICATION - SECONDARY BOW
To Relieve Soft Top Tension for Easier Closure.

A number of instances have been brought to our attention where Dealers and owners have found the soft top assembly very difficult to erect feeling that the soft top assembly fabric has been cut too short and will not sufficiently reach the header panel and give sufficient compression at the header panel to ensure against water leaks at this location, not to mention the difficulty in fastening the hold down hasps on either side.

1. Remove secondary bow C to main bow D attaching rivets A right hand side and left hand side.
2. Fasten soft top cover assembly to windshield header panel and secure with attaching hasps making sure of adequate compression of soft top cover header weatherstrip to windshield frame.
3. Adjust secondary bow to approximately same location on soft top cover as before making certain maximum play is removed from cover assembly without being drum tight when it can be determined where the rivet relocation holes can be drilled in the secondary bow B using as a guide the existing rivet holes in the main bow, both right hand and left hand sides.

It will be noted the distance between centers of the existing and relocated holes in the secondary bow (A - B) should be approximately 3/8".

4. Refit new rivets.

Approximate modification time 1.5 hours.

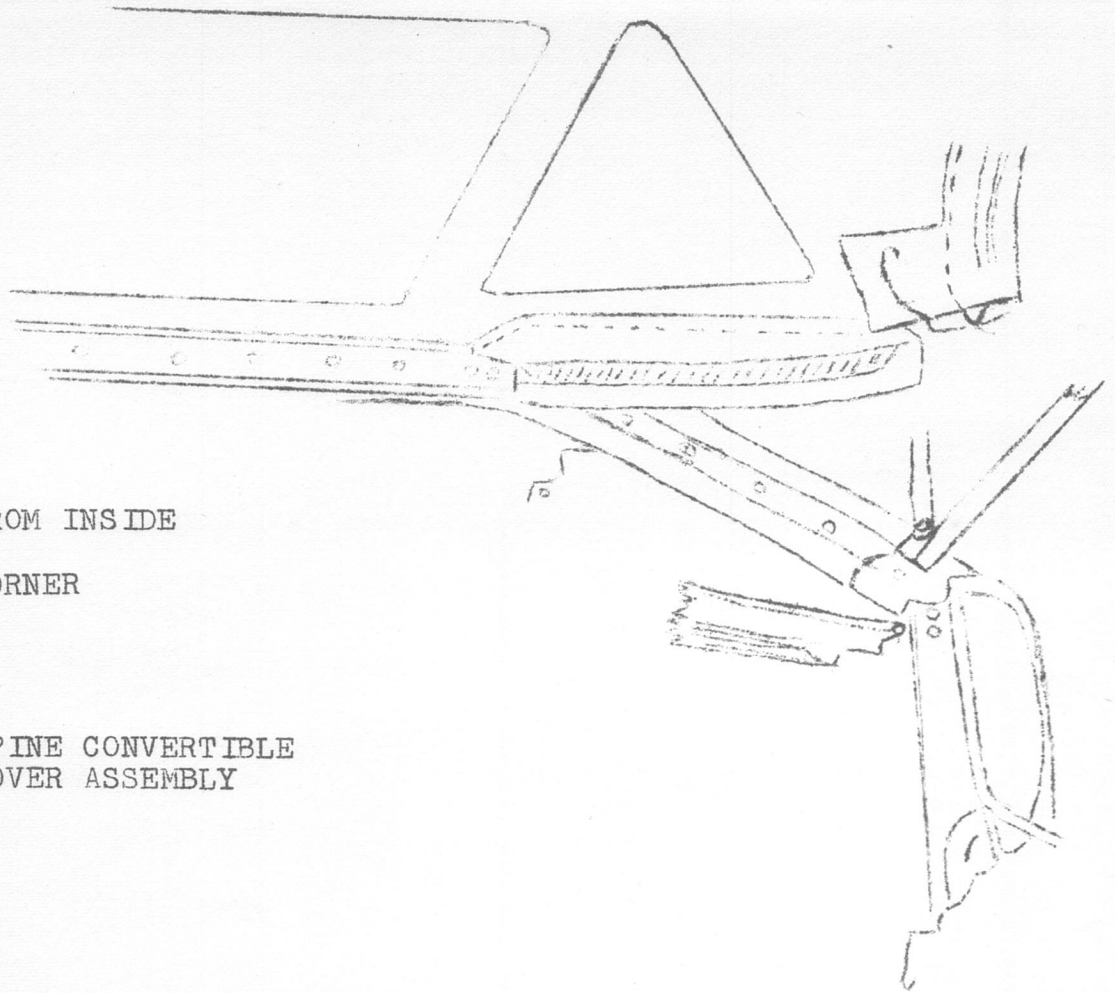
SUGGESTED MODIFICATION REPLACING ZIPPERS

It should also be noted that the zippers as fitted to early production units should not be zipped or unzipped when the Convertible top cover is fastened to the header panel. Such action puts an undue strain on the zippers and readily tears them out. All owners should be fully instructed that the zipper should not be operated until the soft top assembly has been released from the header panel.

1. Remove top cover.
2. Remove torn zipper sections from top cover as well as from periphery of belt molding.
3. Fabricate double skinned vinyl strips approximately 2-7/8" wide and 20" long and insert 5/8" welting the length of the strips between the skins and stitch on either side of welting to assure positive location. Note: Welting should be so located that when the side hood stowage panels are pressed in the closed position the edge of the stowage panel that abuts the body waist molding will compress against and atop the welting at all points along the periphery of the body waist.

4. The fabricated vinyl panels should then be sewn to the soft top cover assembly in the same location as was the previous zipper.
5. To insure removal of all soft top cover wrinkles which may present themselves in the locations of the rear quarter and rear vinyl windows, two dot fasteners should be installed on each side of the soft top cover with the reciprocal portion of the fastener installed in the outer body metal - per sketch attached.
