February 12, 1962

TO: ALL ROOTES GROUP DEALERS

WINDSHIELD ASSEMBLY - FITTING AND REMOVAL

SUNBEAM ALPINE

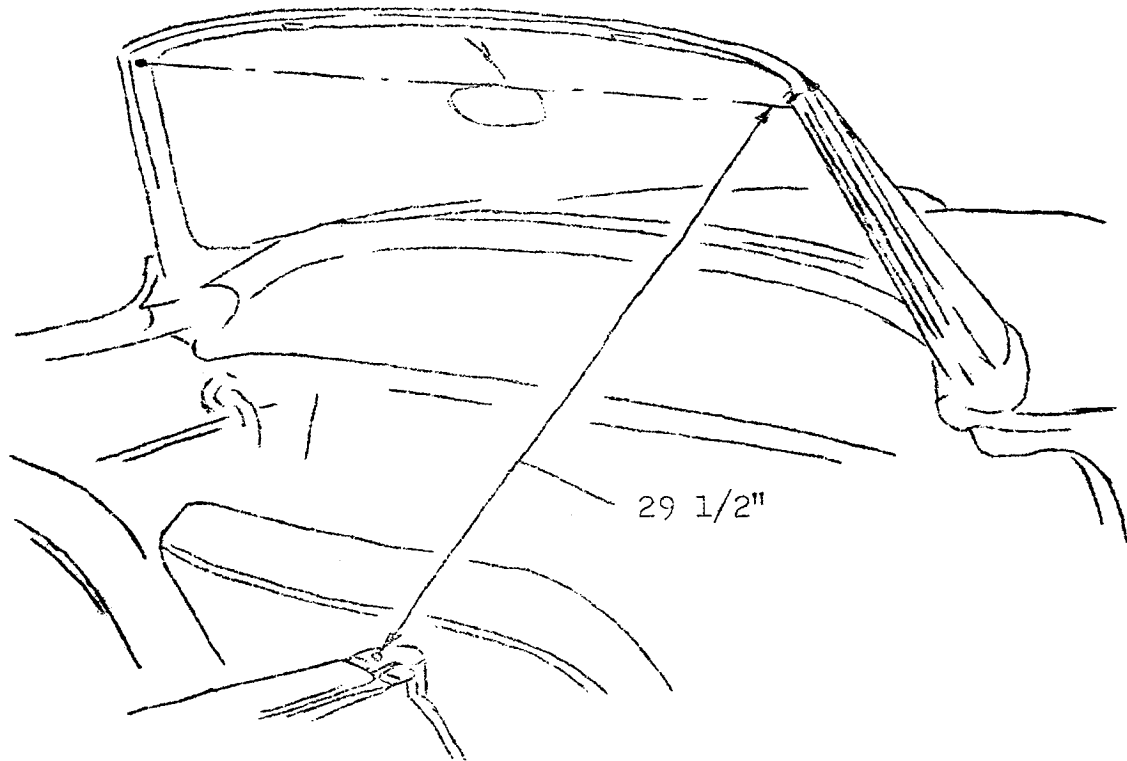
Fig. 2. Showing correct measurements between screen pillar and pivot bracket.

Check that the dimension between the stud on the inside top corner of the windshield pillar and the hole in the pivot bracket on the door shut pillar is to the specified measurement of $29\frac{1}{2}$ ins. as shown in Fig. 2.

If this dimension is more, or less, than the specified amount, then the windshield assembly must be packed with shims (Part No. 2201893) at the four end studs to achieve the required degree of tilt. When the dimension is correct, a liberal amount of sealing compound is applied between the windshield base weatherstrip and the scuttle top (Fig. 3 Op. 1).

After the required measurement has been achieved, tighten up the windshield assembly retaining nuts (two at each side and three across the front), taking care not to overtighten them as this may split the rubber weatherstrip at the scuttle top. Recheck the measurement after tightening the nuts.

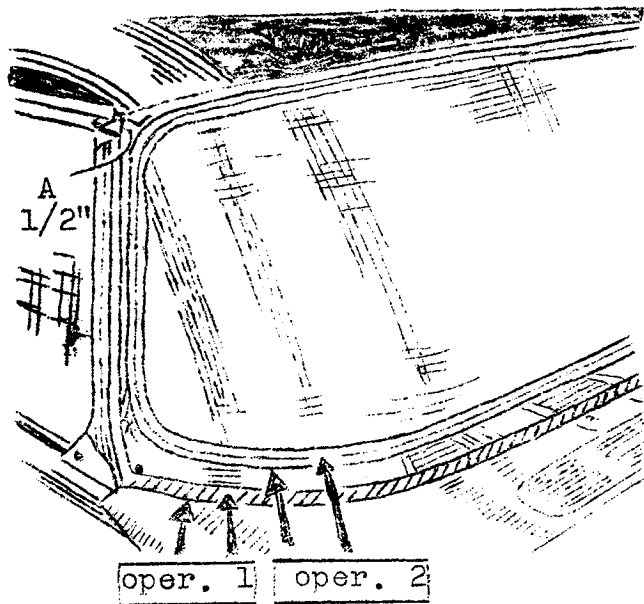
Fig. #3. Windscreen sealing

When correctly fitted, the ends of the seal should cover and compress on to the windshield side pillar seals and should protrude beyond them by approximately $\frac{1}{2}$ in. as shown in Fig. 3 (a).

If the weatherstrip is wrinkled or folded under itself, a new weatherstrip (Part No. 2207539) must be fitted. The seal must be located centrally and not stretched during fitting.

Apply a coat of sealing compound to the area of the weatherstrip which is in contact with the outside face of the glass (Fig. 3 Op. 2), and fit weatherstrip to the glass.

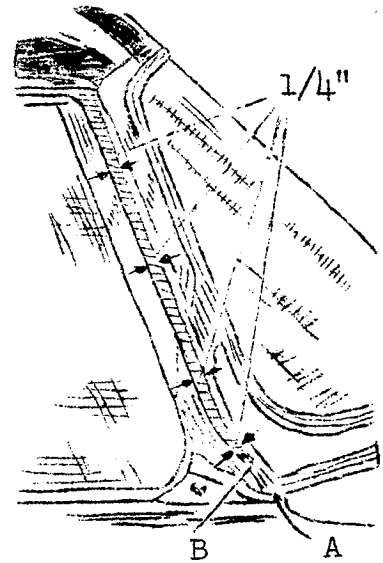
Fig. 4. Correct relation of windscreen side pillar weatherstrip to chrome door support.

In order to ensure a satisfactory seal between the door window support and the windshield side pillar, there should be $\frac{1}{4}$ in. gap from the forward edge of the door windshield side pillar. This measurement should be consistent throughout as shown in Fig. 4 (a). If the side pillar weatherstrip (Fig. 4 b) has acquired a permanent "set" due to misalignment or crumpling it should be renewed. Further, the side pillar weatherstrip should be trimmed flush at its lower edge so that it just brushes on the top of the door window support when the door is closed. This latter item can be applied to both Series I & II cars.

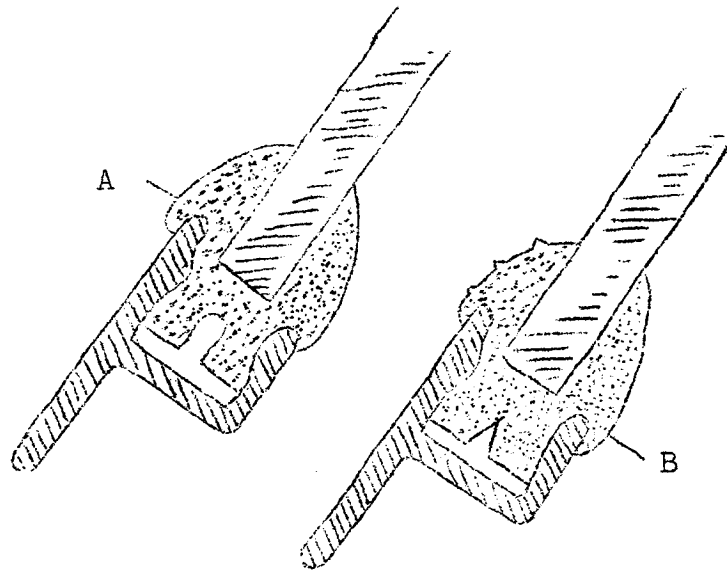
Fig. 5. Correct way of fitting weatherstrip to the windscreen and bottom channel.

Reference should be made to Fig. 5 as to the correct way to fit the weatherstrip to the glass and bottom channel. "A" shows early cars and "B" later cars. It should also be noted at this juncture that the wide notches in the rubber are at the top.
