TO: ALL ROOTES GROUP DEALERS  
MODEL: HILLMAN-SUNBEAM & HUMBER  
SUBJECT: FLASHER SWITCH WITH DELRING SPRING

SERVICE BULLETIN NO. N-3 - ELECTRICAL SYSTEM

PAGE II OF III  
AUGUST, 1964

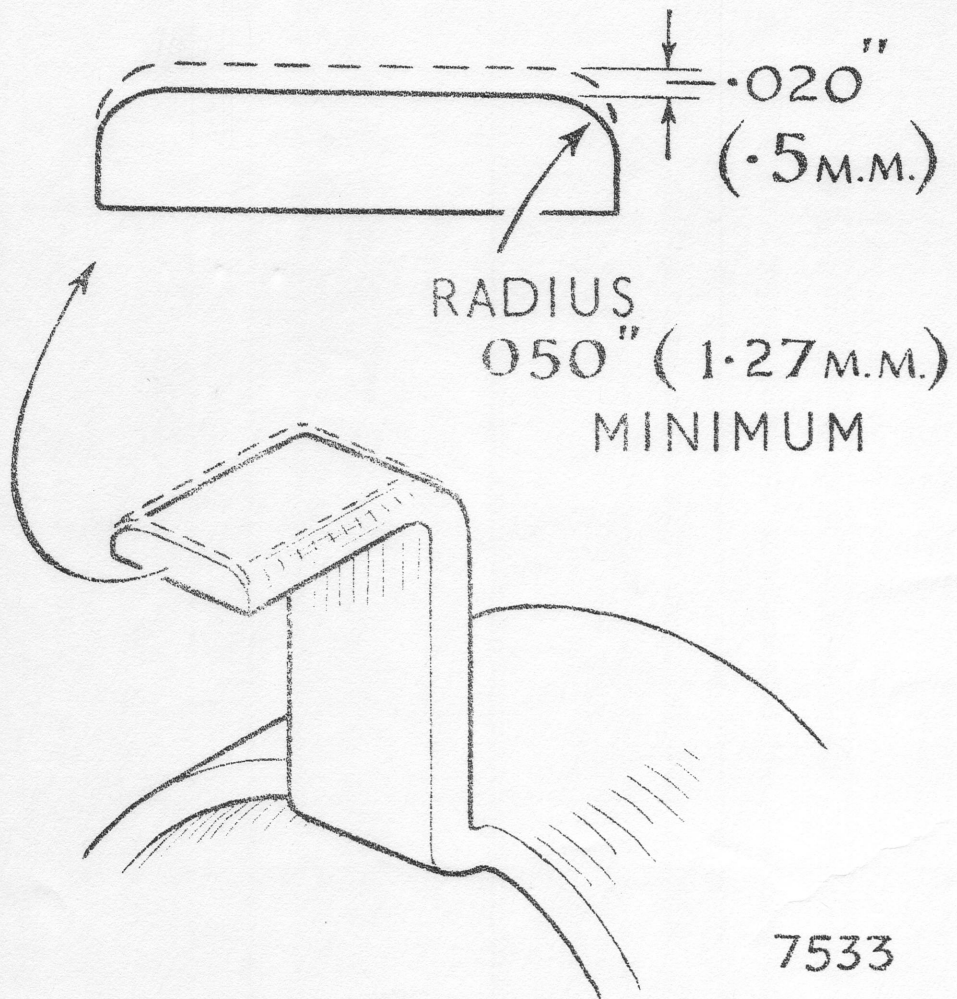
7533

In cases where repeated failure of the white Delrin plastic springs within the trafficator flasher switch have occurred, it is recommended that the following points are checked:-

FLASHER SWITCH STRIKER

2. The striker face should be reduced by approximately .020" (.5 mm) in accordance with the accompanying illustration.

At the same time, it is important that the .050" (1.27 mm) minimum radius is reformed, otherwise the striker will impinge too abruptly onto the Delrin material and lead to a further failure.
