No. 0-5

SEPT. 1965

TO: ALL ROOTES GROUP DEALERS
MODEL: SUNBEAM IMP
SUBJECT:
SUBJECT: BATTERY CORROSION OF INNER WING PANEL.

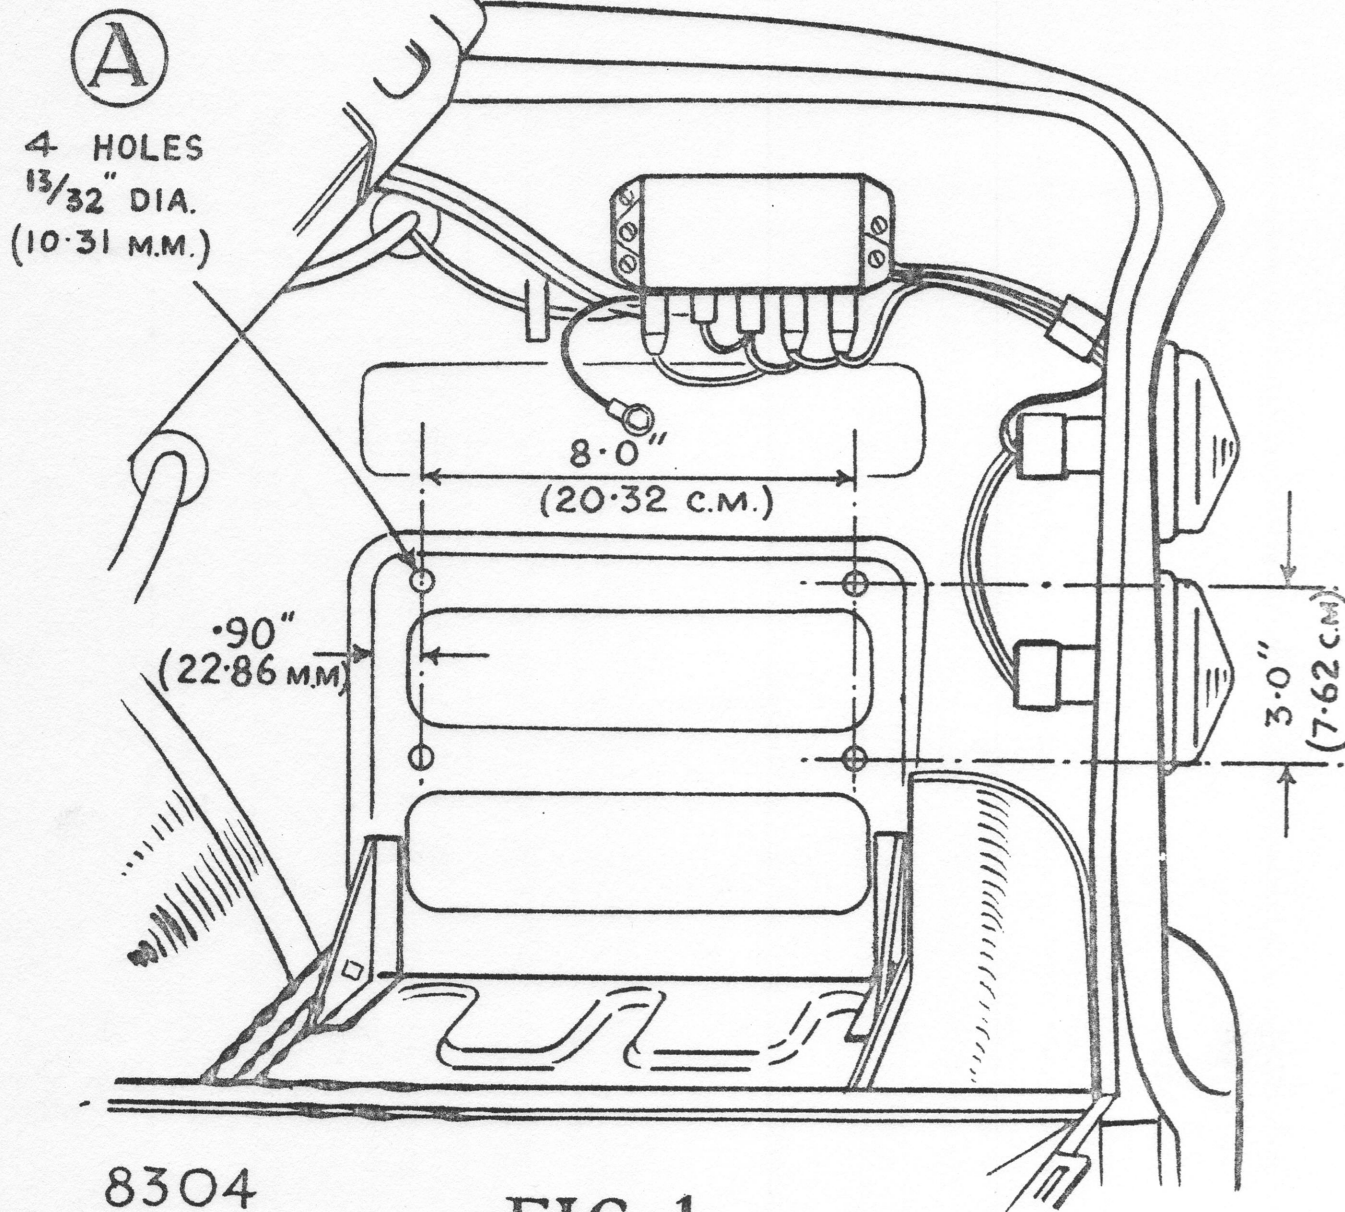
FIG. 1

A number of cases have been brought to our attention where the offside (RH) rear inner wing panel adjacent to the battery has been corroded due to contamination by battery acid or fumes. In most cases this condition has been due to over-filling of the battery and we would remind you that the correct level is in line with the top of the separator guards, i.e. under the perforated splash guard.

Where perforation of the inner panel has occurred, it is recommended that the inexpensive Repair Kit, Part No. 7096094 (containing fibre glass panel, distance piece and bolt) is fitted as per the following instructions:-

1. Remove battery insulating strip and earth lead from panel.
2. Clean off the affected areas and neutralise any remaining acid, using a liberal application of soda and water. Thoroughly rinse and dry off.

3. Paint the affected areas with the appropriate primer and allow to dry.
4. Apply a length of self-adhesive tape large enough to cover the perforations. It is suggested that Fablon or a similar material is used. Refinish the area in the appropriate body colour.
