MODEL AFFECTED - SUNBEAM IMP

ACTION - MODIFICATION OF STEERING
COLUMN

INSTRUCTIONS FOR THE REMOVAL AND REFITTING OF A NEW INNER COLUMN
EXAMINATION OF THE PINION SPLINES AND IF NECESSARY
REPLACEMENT OF THE STEERING UNIT

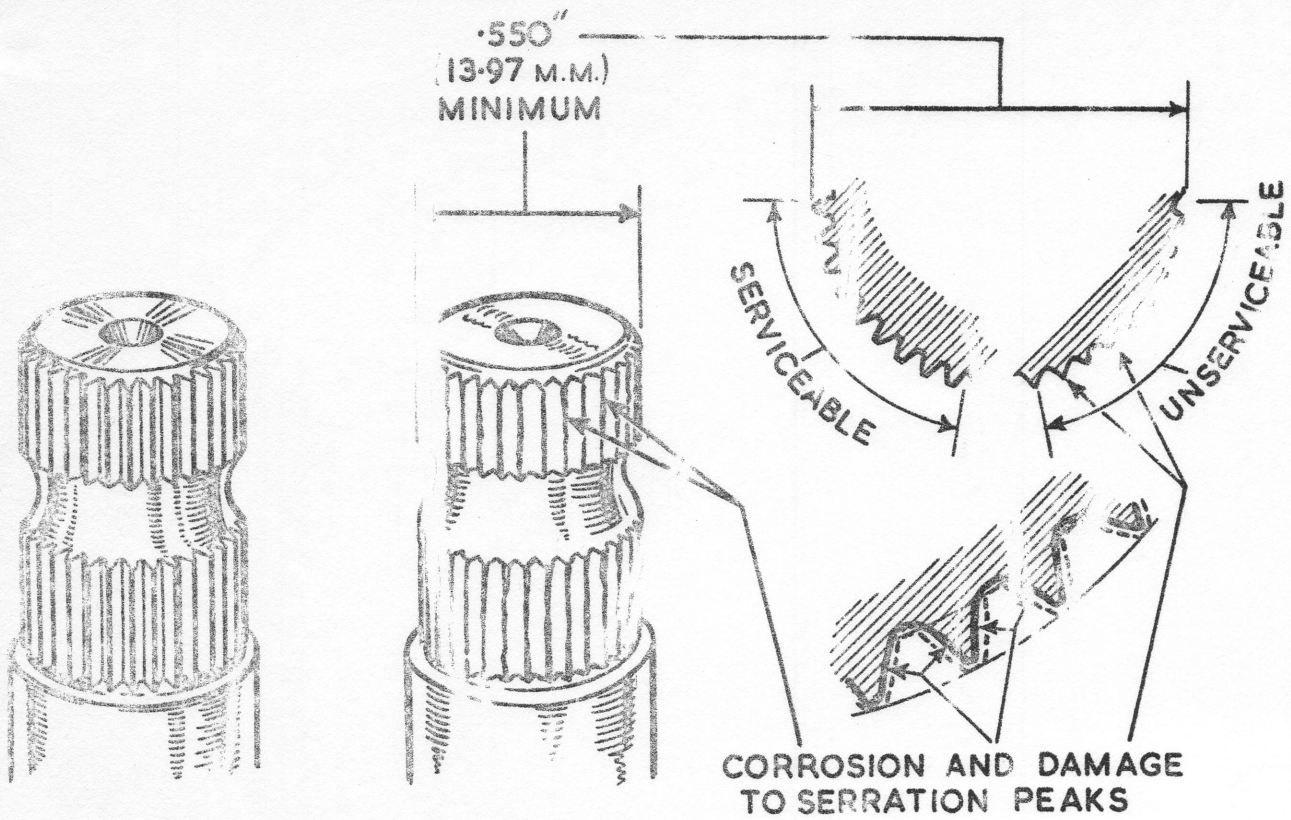
FIG. 1

After considerable mileages, it has been found that in isolated cases, wear has occurred between the steering column/rack and pinion serrations. This has given rise to free play in the steering and knock.

SERVICEABLE

UNSERVICEABLE

1. Remove the steering unit inner column, having first removed the steering wheel, trafficator pawl unit and outer column.
2. Using a suitable wire brush, thoroughly clean the pinion splines on the rack and pinion unit and then examine splines for any signs of flank wear, corrosion, etc., as illustrated in Fig. 1. If you have any doubt at all as to the condition of the pinion splines, the measurement across the peaks of the splines should be taken in three different positions, using a suitable micrometer as shown in Fig. 2.

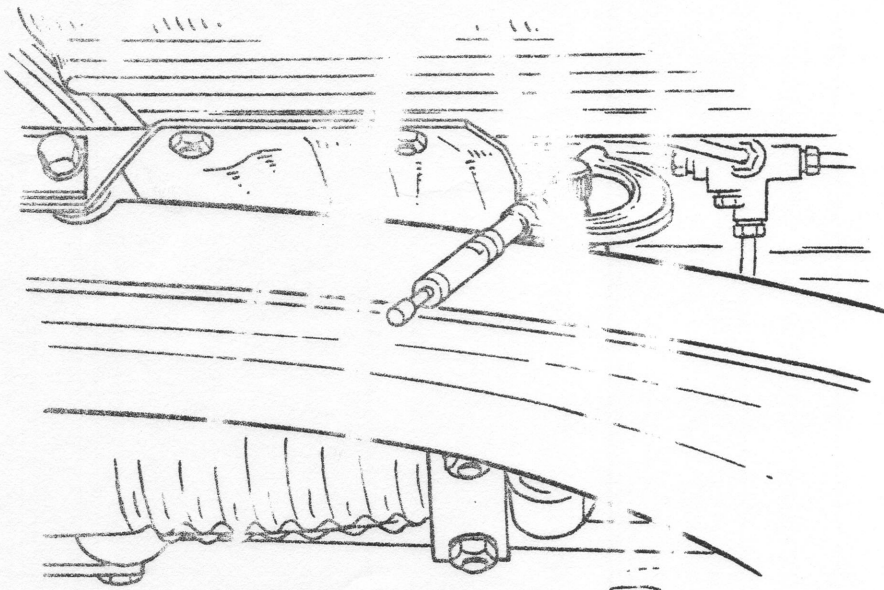
FIG. 2

The minimum permissible measurement across splines is .550" (13.97 mm).

3. If the pinion is found to be in a satisfactory condition, it will not be necessary to replace the rack and pinion unit. However, before fitting the replacement inner column, the 'U' bolt nuts must be slacked off for the reason described in (iv) below. Ensure that the rack and pinion unit is free to rotate.
4. If the condition of the splines is unsatisfactory, or the spline measurement is less than .550" (13.97 mm) the rack and pinion unit must be replaced as follows:-

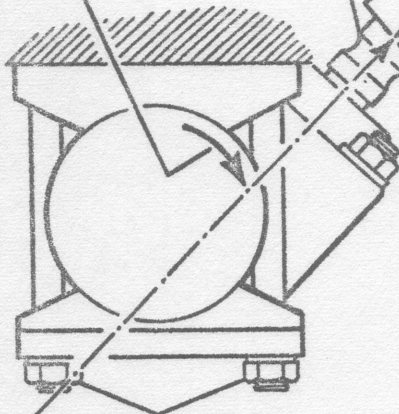
FIG. 3 A

INCORRECT

HIGH

(iv) The rack and pinion unit should be fitted in position, but at this stage the 'U' bolt nuts must not be tightened but left slack enough to enable the unit to rotate. By leaving the nuts loose at this stage, it will allow correct alignment of the inner column to pinion, as shown in Fig. 4. Incorrect alignment is shown diagrammatically in Figs. 3A and 3B.

ROTATE FOR
CORRECT
ALIGNMENT

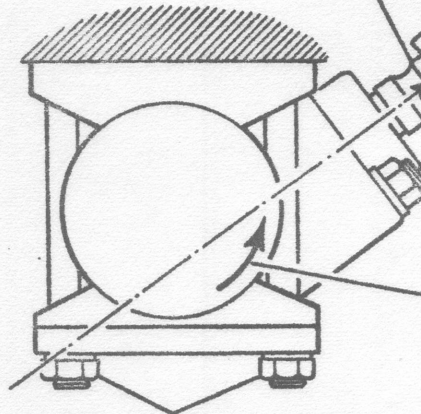
FIG. 3 B

INCORRECT

LOW

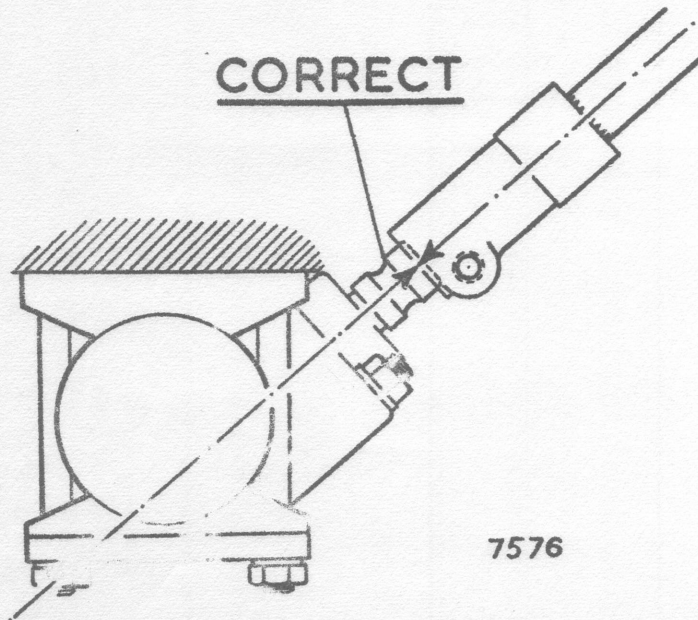
FIG. 4

CORRECT
