4-Me 8
SERVICE BULLETIN

No.
210

December 5, 1960

POSSIBILITY OF CHOKE CABLE FOULING THE THROTTLE
OPERATING SHAFT LEVER - SERIES IIIB 'EASIDRIVE'

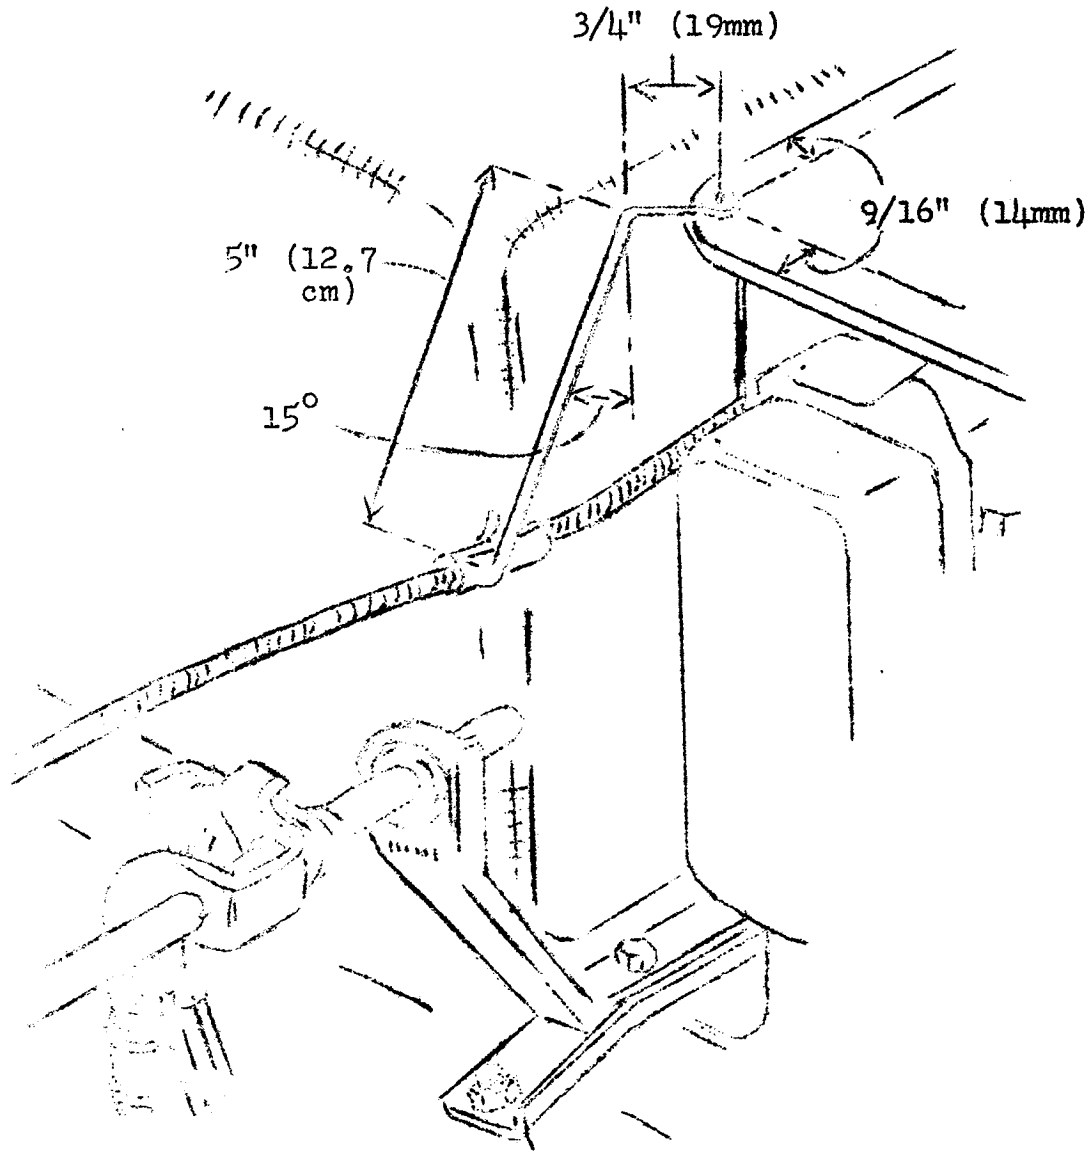
SERVICE BULLETIN NO. 210

We wish to bring to your immediate attention that on Hillman Minx Series IIIB Easidrive cars there is a possibility that a foul may occur under certain operating conditions between the throttle operating shaft lever and the choke cable, which could result in the throttle being retained in the partially open condition.

Dealers are requested to make up from 14 SWG (2 mm diameter) welding wire a retention clip for fitting in accordance with the attached drawing. (This should be painted black). These clips should be fitted to all Hillman Minx Series IIIB vehicles with Easidrive Transmission which have been delivered. Where cars are in the hands of owners, suitable action must be taken to call them in so that the described attention may be given without delay.
