No. B-10

MODEL: SUNBEAM IMP

SUBJECT: ENGINE OIL FILTER FELT SEALING RINGS.

SERVICE BULLETIN B-10

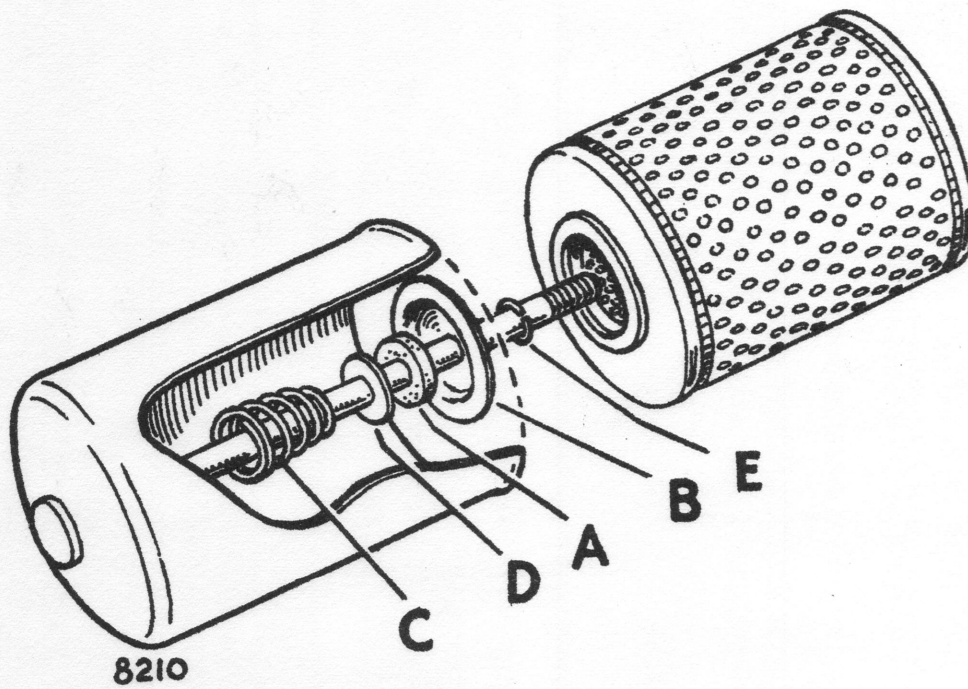
See: Illustration No. 8210.

Further to Bulletin B-5 issued in July 1964, we would remind you how extremely important it is to check that the felt washer, 'A' on illustration, is correctly positioned and not damaged when replacing the oil filter element.

In order to overcome damage to the felt washer, a small circlip 'E' is now fitted to the centre stud 'C', so preventing the filter element support plate 'B' attaching itself to the element on withdrawal.

When replacing the oil filter element on units prior to the introduction of the circlip, great care should be taken to ensure that all the components shown on the attached illustration are in good condition and fitted in the correct order.

In the near future, all replacement oil filter element packs supplied by Rootes Motors (Parts), Limited will contain a spare circlip, which should be fitted to those units not already incorporating one; a leaflet is included in the box instructing that this action is taken.

Additional circlips, Part No. 7080251, are available through the normal Parts channels.
