SUSPENSION AND  
DAMPERS.

No. H-2

TO: ALL ROOTES GROUP DEALERS  
MODEL: SUNBEAM TIGER, (260),  
SUBJECT: PANHARD ROD BRACKET FAILURE

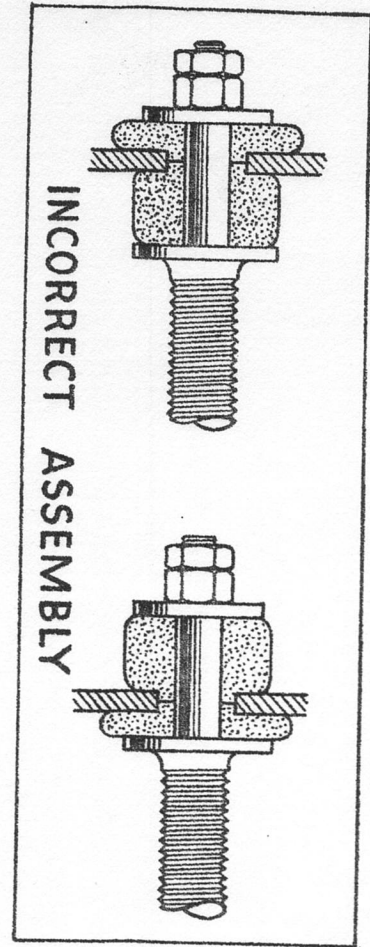
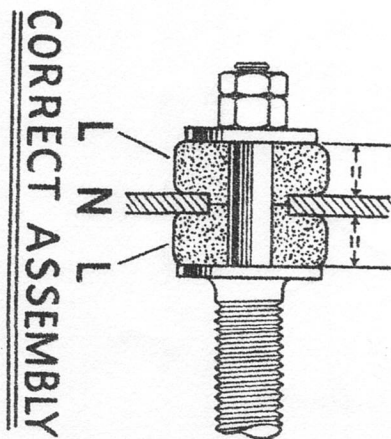
In order to minimise the possibility of Panhard Rod Bracket failure on the above model, all cars prior to Chassis Number B.9473544 should be checked at the next Service call to ensure that the correct washer, Part Number 9067044, is fitted at the chassis frame end of the Panhard Rod as shown on the attached illustration.

Both locknuts 'M' should be removed together with the plain washer 'F'. The internal diameter of this washer 'F' should be 25/64" (2.9 mm.); if greater, the washer must be replaced with Part Number 9067044, and the old washer discarded.

The new washer should be fitted, both locknuts retightened and the Panhard Rod adjusted as follows:-

1. Load vehicle with 165 lbs. (75 kgs.) in the boot, 20" (50 cms.) rearwards on the centre line of the rear axle.
2. Slacken locknut 'J' and adjust Panhard Rod tube 'K' by turning it clockwise or anti-clockwise until the rubber bushes 'L' mounted on either side of the Panhard Rod bracket 'N' are of equal thickness, i.e., when there is no tension or compression in the rod, as shown.
3. Tighten Panhard rod locknut 'J' and remove weights from vehicle.
