No. B-5

JULY-1964

TO: ALL ROOTES GROUP DEALERS  
MODEL: SUNBEAM IMP  
SUBJECT: OIL FILTER

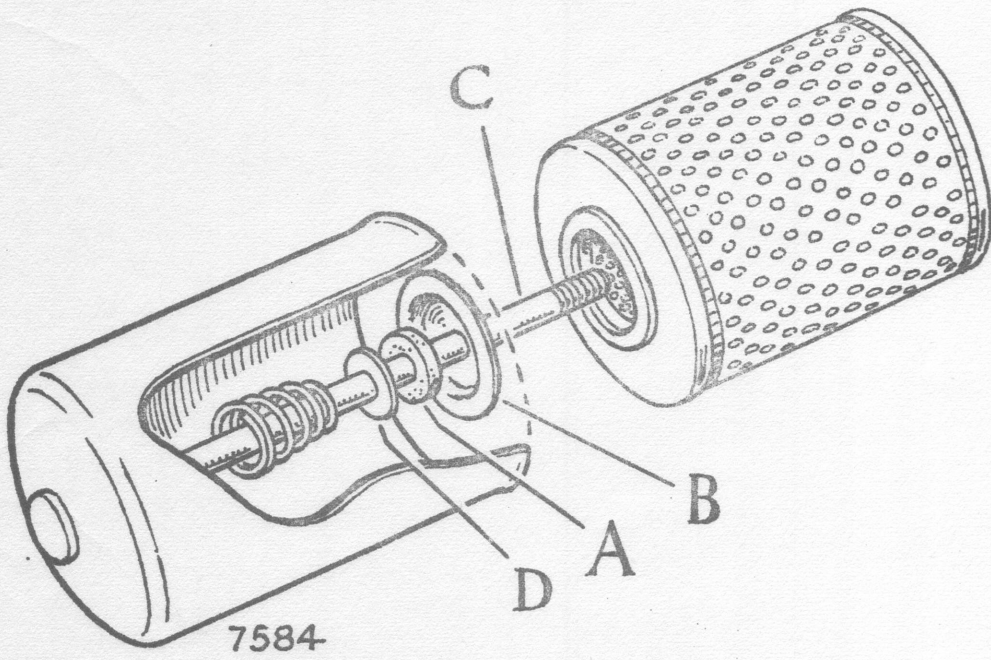
jd  
Enc. - Sketch 7584

We wish to bring to your attention the necessity to ensure that the felt washer 'A' shown on the attached illustration is not damaged when the filter element is removed.

When replacing the element, ensure that this washer is not trapped between the element support plate 'B' and the center stud 'C'. If the support plate is omitted or the felt damaged, particles can be carried by the lubricating oil round the engine and result in complete loss of the oil pressure and subsequent engine damage.

When changing the oil filter element, therefore, it is vital to ensure that:-

- (1) The felt washer is in good condition.
- (2) It is not damaged while fitting the replacement element.
- (3) The support plate and steel washer 'D' are correctly positioned.
