TO: ALL ROOTES DEALERS

MODEL: SUPER MINX III, MINX V
(FLOOR GEAR CHANGE & BORG WARNER
MODELS ONLY)

SUBJECT: TRAFFICATOR SWITCHES

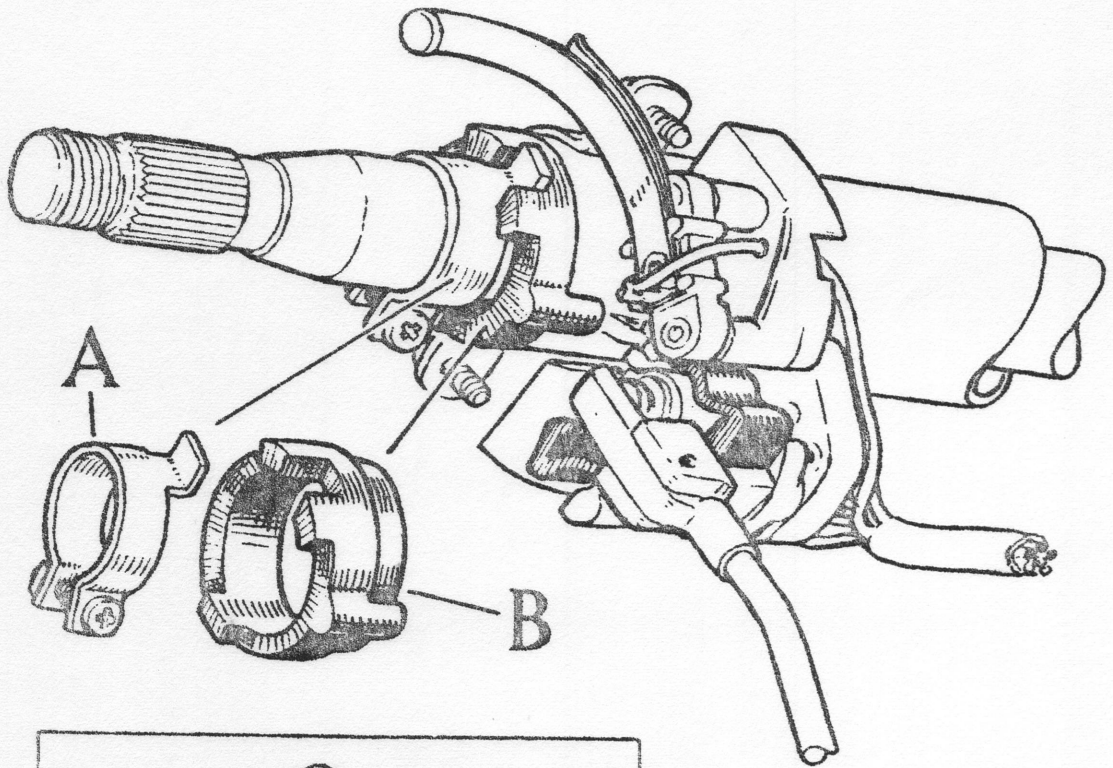
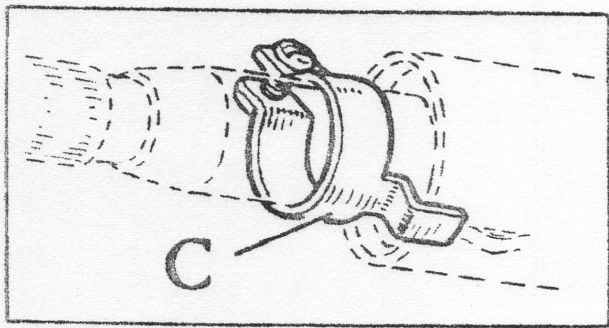
8069

Within the Chassis Number range shown below, a modified type of trafficator switch striker was introduced.

This consists of a WHITE Delrin striker bush (B) positioned in the top of the outer column and a metal driving link (A) as shown on the accompanying illustration. The trafficator switch remains the same as previously fitted to these models.

Where difficulties are encountered with the trafficator switch mechanism on these cars, proceed as follows:-

1. Too shallow striker engagement giving lack of trip or too deep engagement causing trafficator to trip onto the opposite lock. DISCARD white Delrin striker bush (B) and metal driving link (A) and fit metal striker ring (C), Part Number 1229618.
2. Any other trafficator switch complaint, replace switch Part Number 1223746 or 1223747 as applicable.
